Photographic record of The Mayfair Ballroom and Mayfair site in context

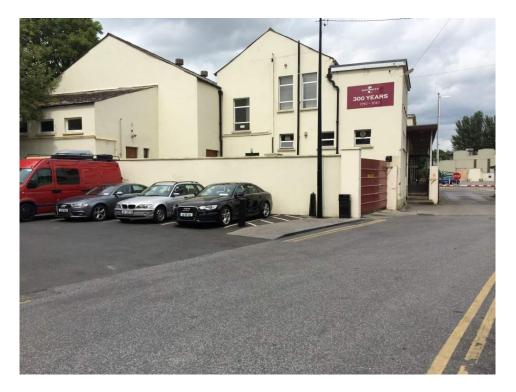
Contextual context of building with car park to front

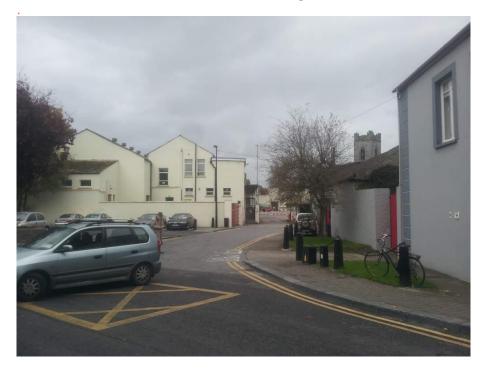
View of south elevation showing double pitched roof.

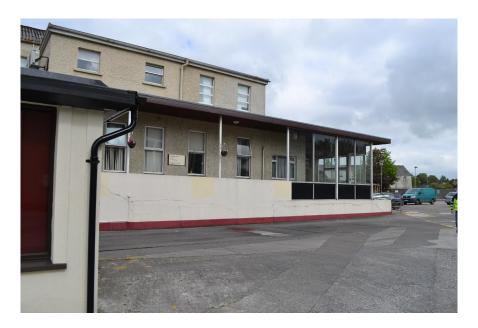
View of car park to South side of building in context

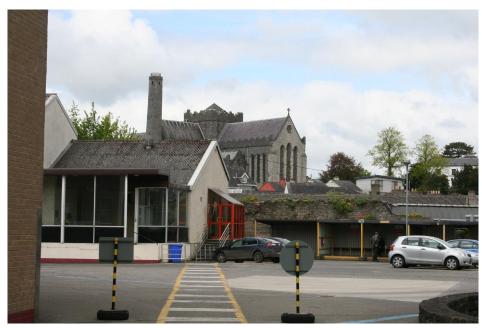
External canopy which is not coeval to the structure

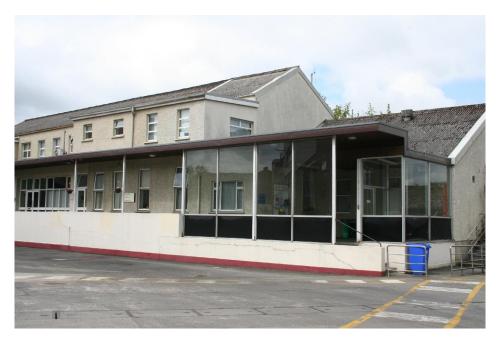
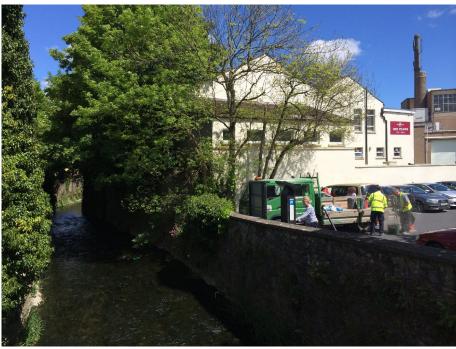
Asbestos roof of main structure. St Canice's Cathedral to rear. And city wall to rear

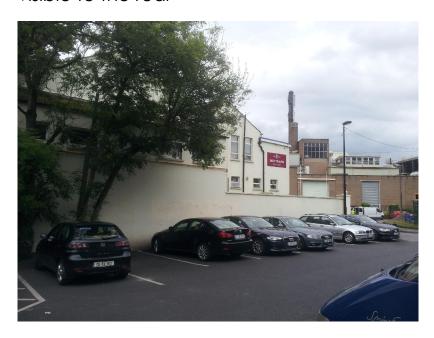
The south elevation of the dance hall showing the extended outdoor terrace which is not coeval to the building. The pitched roof is asbestos. The city wall is visible to the rear

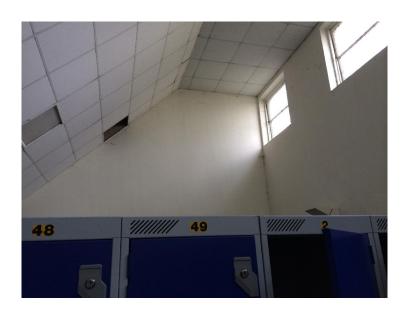
Interior showing doors and ceiling tiles not coeval to the dance hall structure

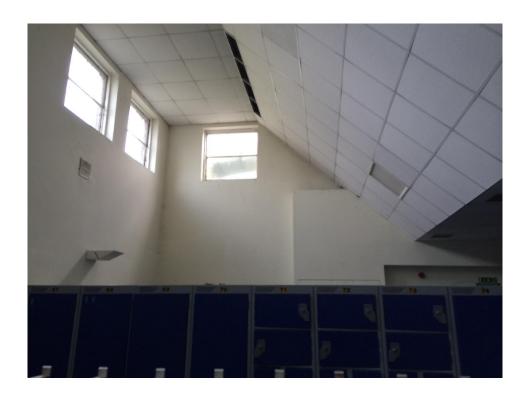
Interior photo showing form of trusses of the smaller pitch roof .The ceiling tiles are not coeval to the structure

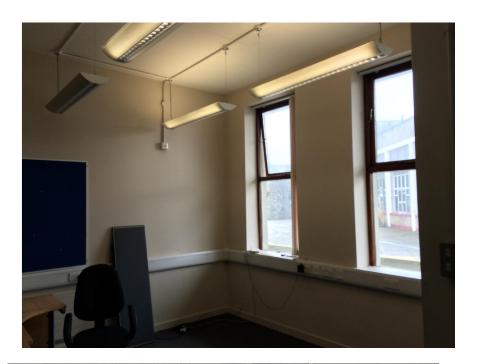
Interior photo showing former dance hall. The large trussed roof cannot be viewed due to ceiling tiles

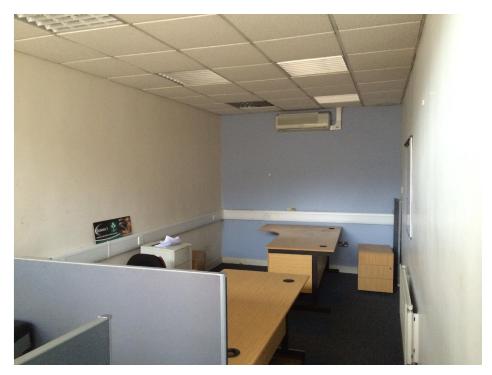
Interior of office showing ceiling tiles and doors which are not coeval to the original structure

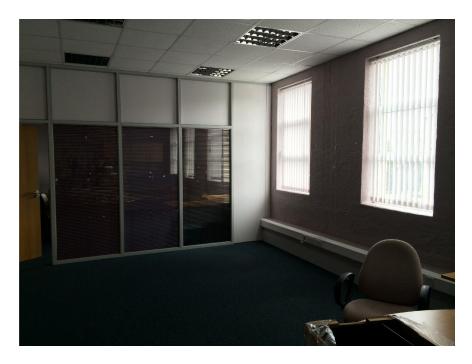
Interior of office showing ceiling tiles and doors which are not coeval to the original structure

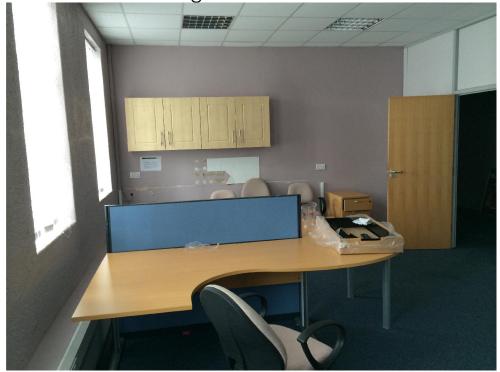
Interior of office showing ceiling tiles and doors which are

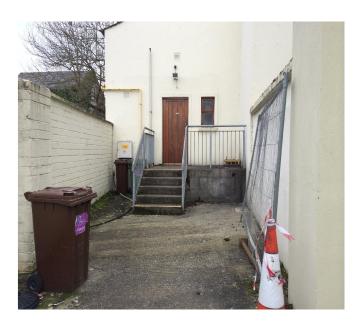
Service Yard to West of Existing Building detail of city wall to right of photo
