**KILKENNY CAS
HOUSES AT 20-22 VICAR STREET**

SUMMARY REPORT ON BUILDING INVESTIGATION

**Historic Building Consultants
Old Bawn
Old Connaught
Bray**

14th April 2014

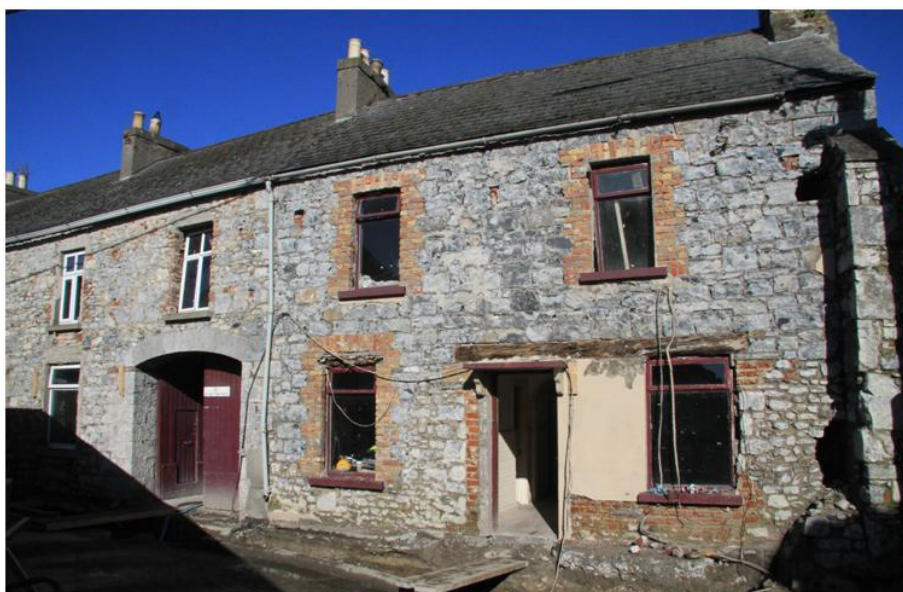
Plate 1: Front of numbers 21 (left) and 22 (right)

The photograph above shows the front facade of number 22 and most of number 21 after the removal of the render from the front facade. The red brick around the windows of number 22 is typical of the early twentieth century and dates from the reconstruction in 1908. The majority of the stone in the facade is from the same period, though some at the very bottom to the left of the door is earlier – possibly as early as the eighteenth century, but not earlier. The brick around the windows in number 21 is typical of the later nineteenth century, which is consistent with the date of 1881 for this building. Both houses have areas of concrete on their facades, representing the work carried out in the 1930s.

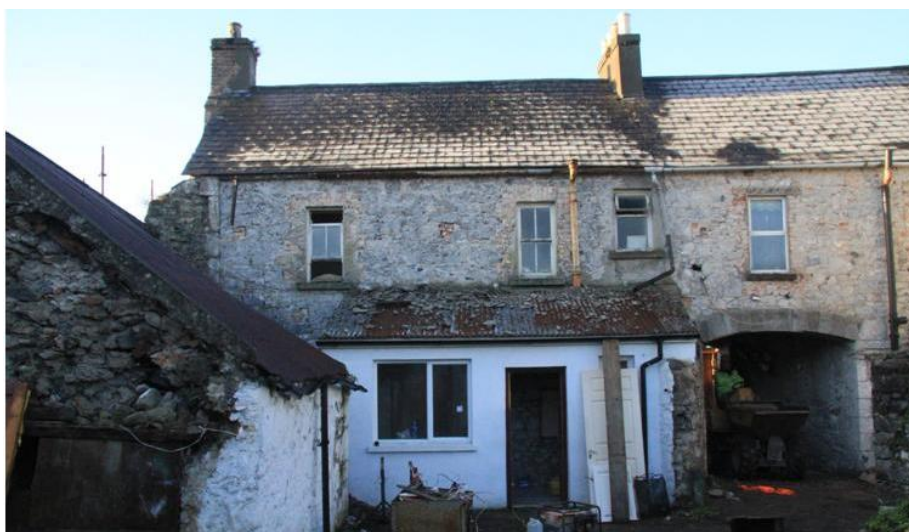
Plate 2: Rear of number 22 (left) and part of number 21 (right)

The removal of the render from the rear of the houses showed a similar pattern of brick and stone, indicating the same dates for the reconstruction. The lowest part of the rear wall of number 22 has older masonry, probably eighteenth century.

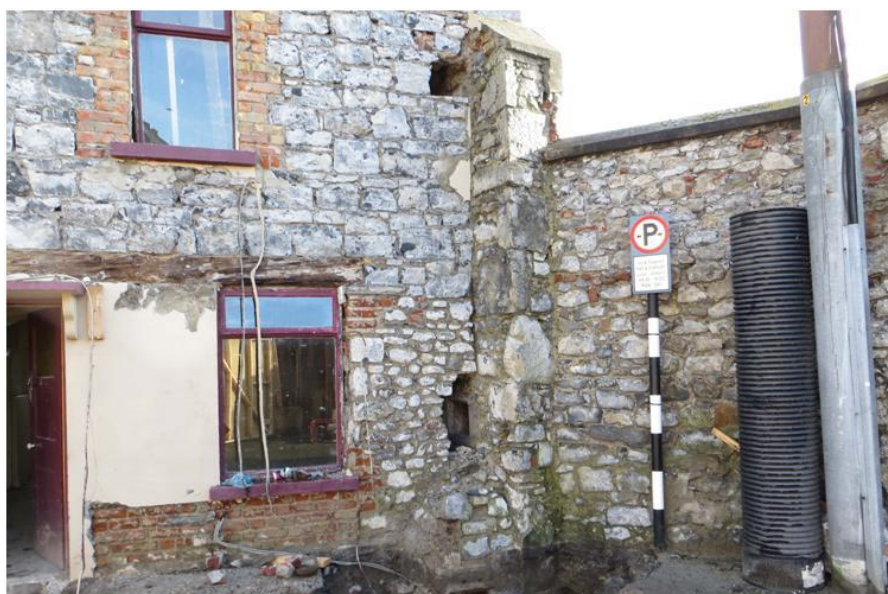
Plate 3: Buttress at front of 22 Vicar Street

A feature similar to a buttress projects from the front of number 22, at the right-hand or southern end. The investigations showed that the front wall of number 22 is built up against the gable end wall, showing that the front wall was built later. The buttress is the end of that gable wall and is built of rubble, some of the stones of which are clearly reused as they have lime-wash on the surface, while other stones do not. There is a significant amount of brick between the stones, suggesting that this end of the gable wall dates from the eighteenth century or later.

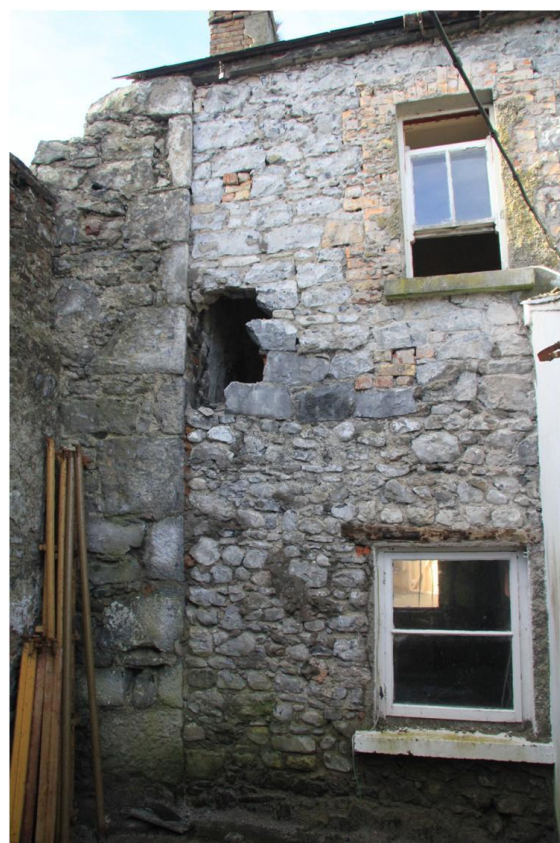
At the back of number 22 the opposite end of the gable wall was revealed when the render was removed. This is not a projecting buttress at the rear, but the corner of a building, embedded in the wall at the end of the rear facade. There are some large stones in this corner, including some that have been dressed, one of which is clearly part of a door or window jamb from the late medieval or early modern period. It is not in its original location, however, and represents the reuse of the stone from some other building. There is a significant amount of brick between the stones of this embedded corner, indicating that it dates from the eighteenth century or later. The rear wall of the house is butted against this feature, showing that it is of later date.

Plate 4: Corner embedded at rear of house

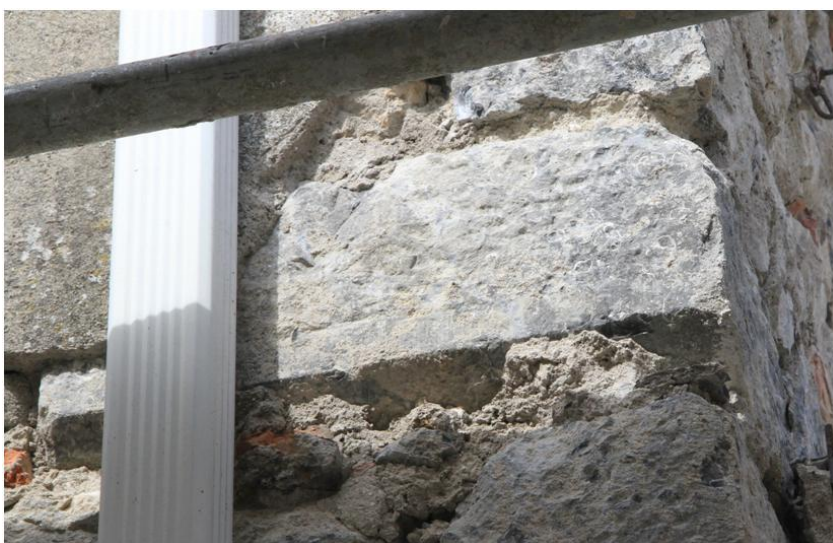
Several stones built into the walls were found to have been cut or dressed and some of these were of late medieval or early modern date. In all cases they appear to have been salvaged from an earlier building and reused. The adjacent photo shows a stone that may be medieval and which is built into a wall that was built in 1881.

Plate 5: Chamfered stone window or door jamb in return at rear

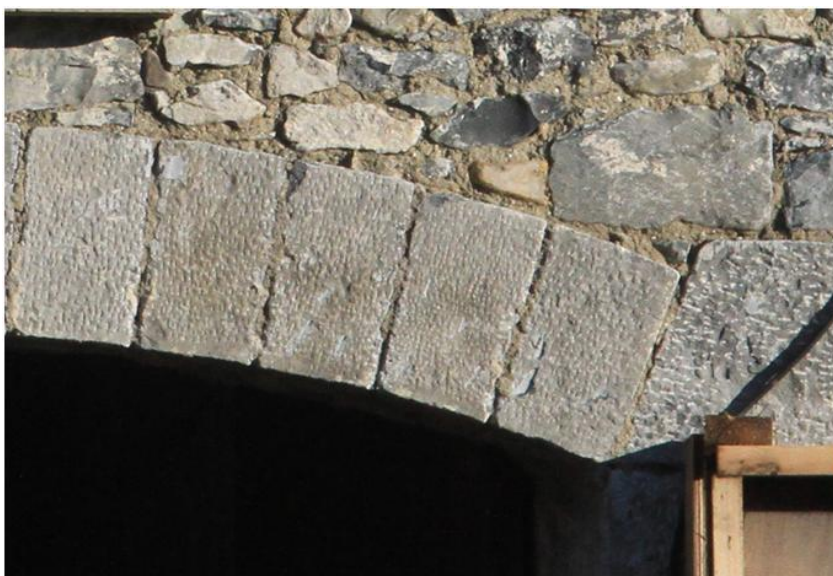
Some cut stone found during the works is in its original location and was provided as new stone during the construction of the houses. Cut or dressed stone was common in buildings until the late nineteenth century at the corners of buildings, chimneybreasts and arches. These are frequently found at railway bridges from the 1830s to the 1890s.

Plate 6: Cut stone in the arch over the carriageway

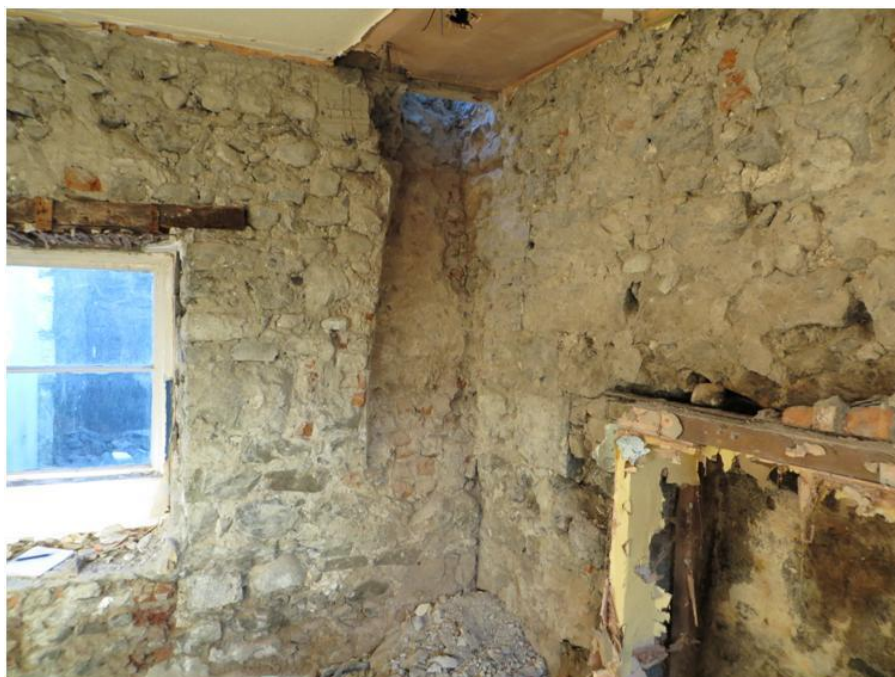
Plate 7: Feature in corner of main ground floor room, 22 Vicar Street

When the render was stripped from the internal walls a feature appeared in the rear corner of the main room on the ground floor of number 22 Vicar Street. This was an area of brickwork on the face of the wall that narrowed towards the top. The brick did not run down to floor level, but stopped a little above the height of the window sill.

After consultation with the Department of Arts, Heritage and the Gaeltacht, it was decided to remove the brick to investigate the rear of the feature. The brick that was removed was a mix of types and many of the bricks were machine-made, with the maker's name stamped into the brick. This suggests that the feature was blocked up in 1908 when the house was rebuilt.

Behind the brick fill there was a channel built into the wall, sloping back into the thickness of the wall as it rose and narrowing towards the top. The rear of the feature was constructed of brick. This feature rose to the level of the ceiling, at which point it had penetrated through about half of the thickness of the wall. The top coincided with the level of the later construction in 1908. When stone was removed from the top of the feature to reveal the adjacent stonework of the end gable wall some soot blackening was seen on the stones.

This feature has been interpreted as a chimney that would have either had some form of canopy, such as the wicker canopies found in many farmhouses and cottages, or, alternatively, a corner chimneybreast. The style of the bricks suggests that this feature dated from the eighteenth or early nineteenth century.

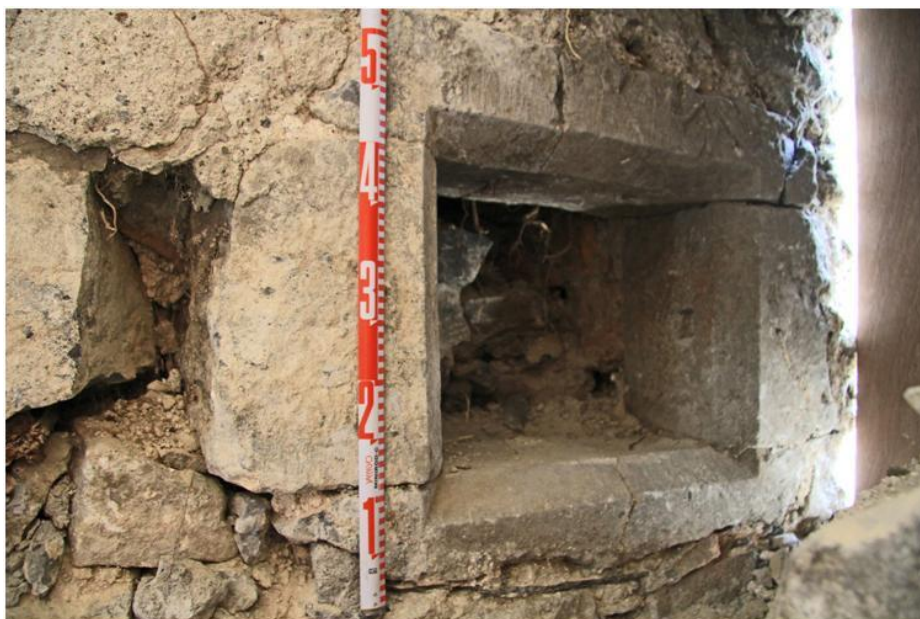
Plate 8: Stone-lined opening in gable wall

The removal of plaster from the walls in the large room at ground floor level revealed a cut stone in the corner of the room. The stone was in the end gable wall, but was partly hidden by the front wall of the house. When stones were removed from the front wall a stone-lined opening was revealed. This consisted of four cut stones with bevelled edges forming the sides of a rectangular opening. Square recesses in the inward-facing sides of the stones would have held bars, with two vertical bars and one horizontal. This opening appears to be a small window

The style of the stonework suggests a late medieval or early modern date and can be compared with the stone found in the rear return of number 21, shown in plate 5 above. It is also similar to a stone built in to the embedded corner at the rear of number 22, seen in plate 4. Both of those stones are from earlier buildings and have been reused. A later date cannot be ruled out and stonework similar to this can be found in the nineteenth century.

The window is an enigma. It does not penetrate through the wall, and the wall at the rear is of brick and stone. There is no sign of it on the opposite side of the wall. If it was originally intended as a recess or cupboard the holes for bars would have no purpose. In its present position it would have been concealed as soon as the front wall of number 22 Vicar Street was built and if it was a window it must have predated the construction of number 22.

One possibility is that this is just another example of dressed stones that have been reused from an earlier wall. The presence of brick at the rear, and also in the wall beneath it and to the left, suggests that this gable wall is no earlier than the late seventeenth or the eighteenth century.

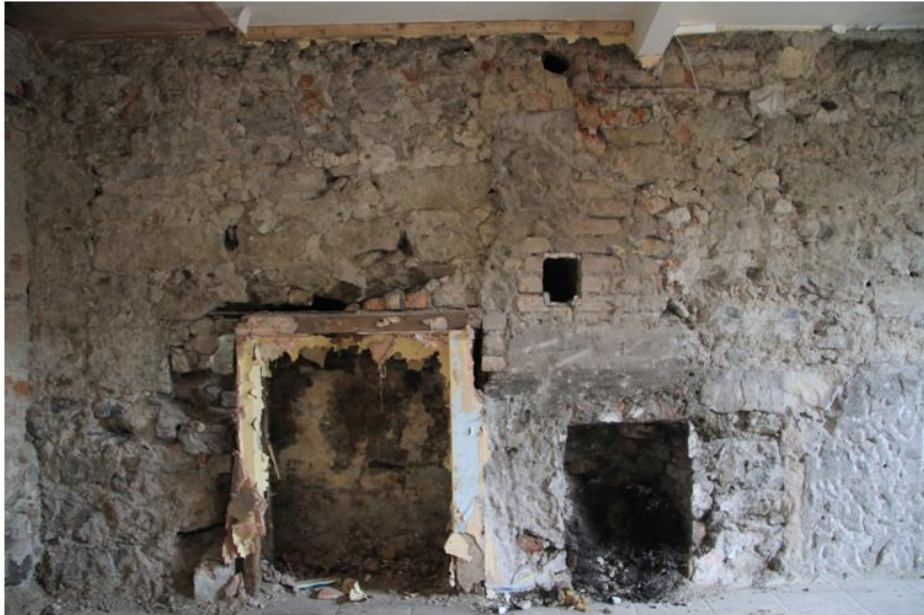
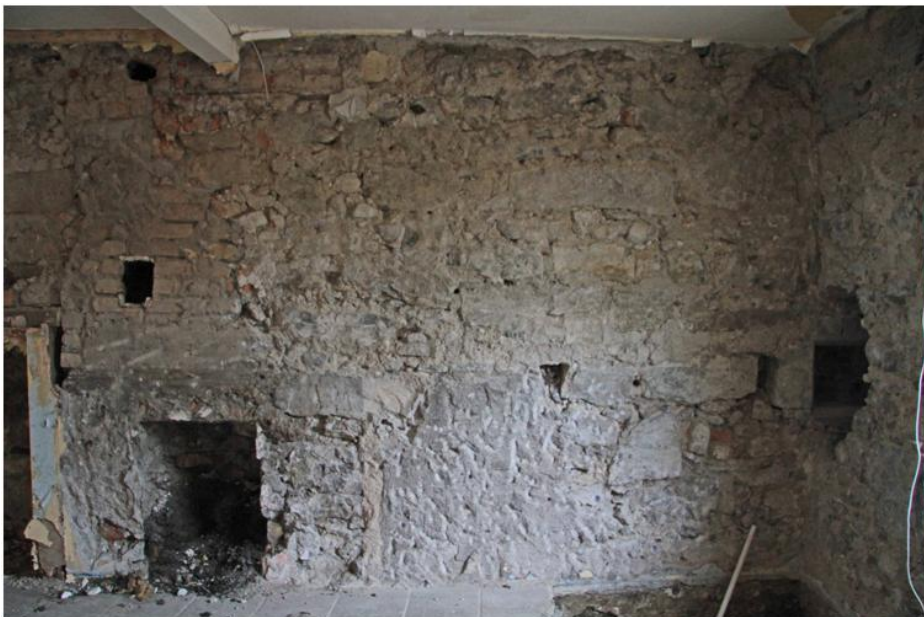
Plate 9: Interior of gable wall at ground floor - left

Plate 10: Interior of gable wall at ground floor - right

The interior of the gable wall at ground floor level has had three fireplaces, in addition to the one in the adjacent wall that was blocked up, and which is pictured in plate 7 above. All three are intrusions into the original wall. Those parts of the wall that have not been affected by these alterations are comprised of rubble limestone. There are fragments of brick through much of the wall, indicating that this wall is not medieval. The fragments are mostly too small to be sure what size the original bricks were and so cannot show whether the wall is seventeenth century or whether it is later. The fireplaces are discussed further below after consideration of the first floor.

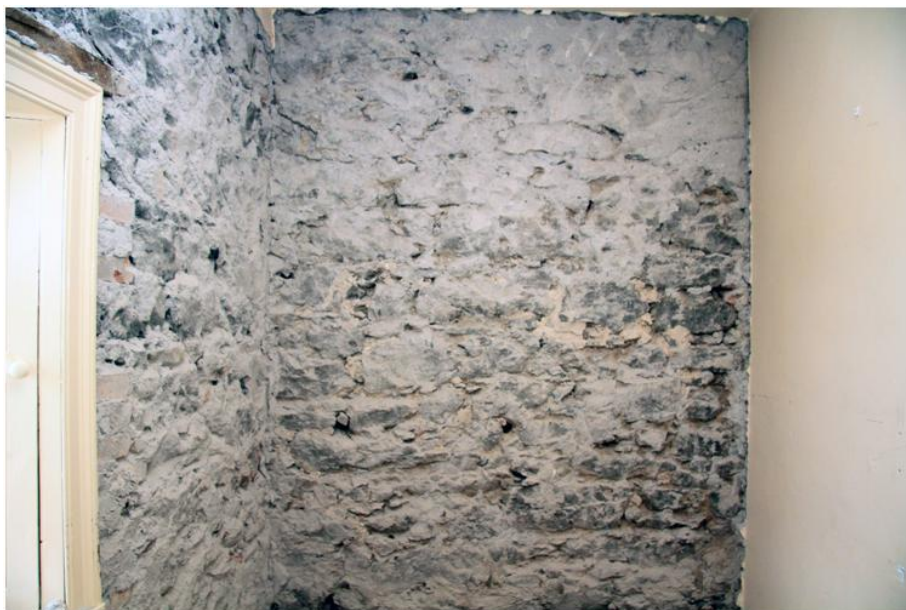
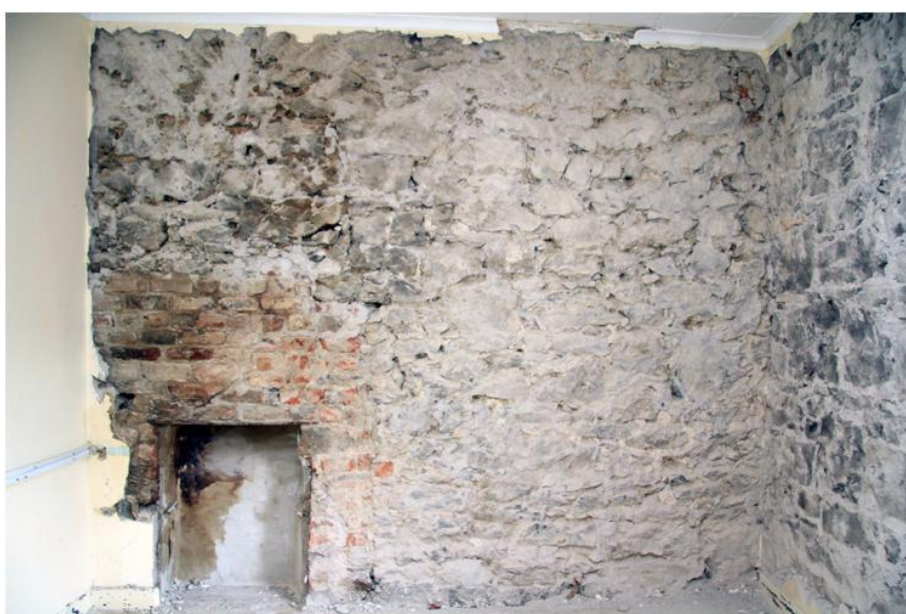
Plate 11: Gable wall, seen in smaller first floor room

Plate 12: Gable wall, seen in larger first floor room

The gable wall in the first floor rooms is built with limestone rubble. There is a small amount of brick in this wall, and as with the ground floor the fragments are too small to indicate what size they were originally. This wall has a fireplace inserted into the centre, with a brick surround. This is discussed further below. The masonry in the main part of the wall is roughly coursed in the left-hand section, over the hearth and in the left-hand room, while the masonry to the right of the fireplace is not coursed. This suggests a possible difference in dates between the two ends of the wall.

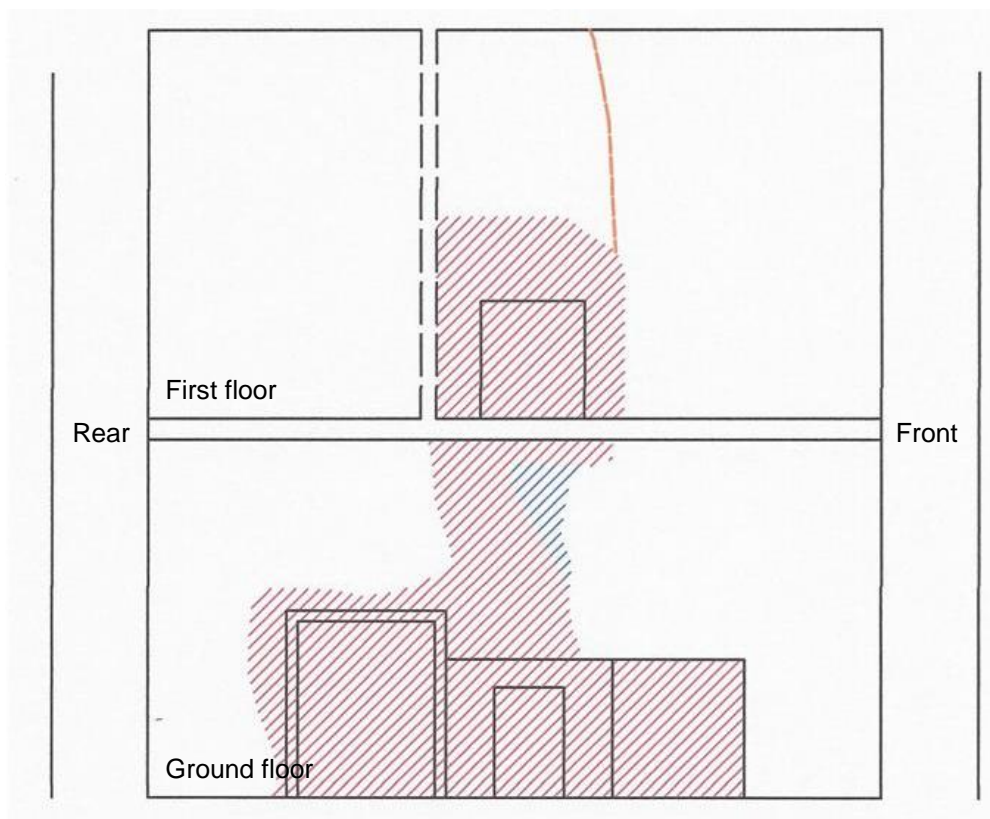
The diagram below indicates the later intrusions into this wall. The red hatched area indicate those alterations that date from the early twentieth century, while the blue hatched area may be either late nineteenth or early twentieth century.

Figure 1: Internal face of gable end wall showing alterations

What appears to have occurred here is that the house that was reconstructed in 1908 had two rooms at ground floor level alongside the gable end wall. Each room was given a fireplace and the old fireplace in the rear wall was blocked up. The provision of these two fireplaces necessitated digging into the masonry of the gable wall, but the flues to serve these fires were taken out through the rear of the wall and did not involve cutting into the masonry over the chimneypiece. At first floor level there was one room and this had its own fireplace, again taking the flue out to the rear of the gable wall. When the house was altered in the 1930s the two rooms were opened up into one large room and a new hearth was provided in the centre of the wall. This necessitated opening up the wall above the hearth to tap in to an existing flue at the rear. The right-hand hearth downstairs was stopped up with mass concrete, while the left-hand hearth was boxed in and turned into a cupboard. This would explain why all of the intrusions into the wall are of twentieth century date, and it is noted that the central fireplace is surrounded by mass concrete and has bricks of a late type stretching up from it. The bricks crossing to the right of the hearth at ceiling level were inserted to support the beam that replaced the dividing wall and are seen in plate 10 above. On the upper floor the opposite occurred, with the division of the room into two, while the fireplace went out of use.

The broken orange line in the diagram shows the boundary between the coursed limestone wall, to the left, and the uncoursed wall, to the right.

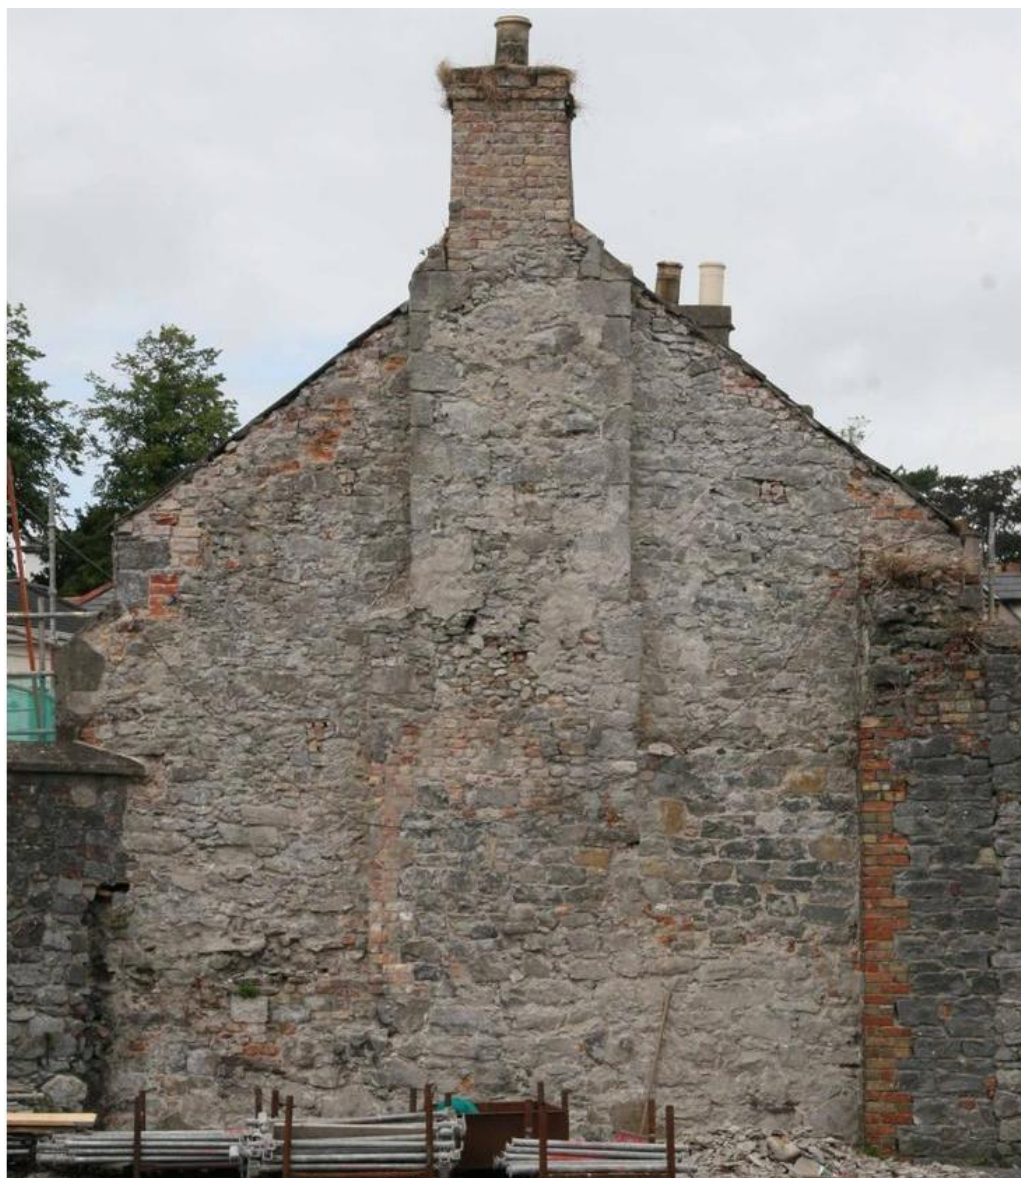
Plate 13: Southern face of gable wall

The southern side of the gable wall, which is the external face, forms part of the northern boundary of the yard or car park owned by Diageo Ltd. As has been noted, this wall is earlier than the present house at 22 Vicar Street and the front and back walls of the house were built up against it. The projecting buttress on the front of number 22 and the embedded corner at the rear of the house have been described above and these are strong indications that this gable wall formed part of an earlier structure that stood on the land now occupied by the Diageo yard. At the right-hand side of the photograph above the column of darker stone, edged with brick, represents a twentieth-century facing onto the rear corner of the building, which is the corner that is embedded at the rear of number 22.

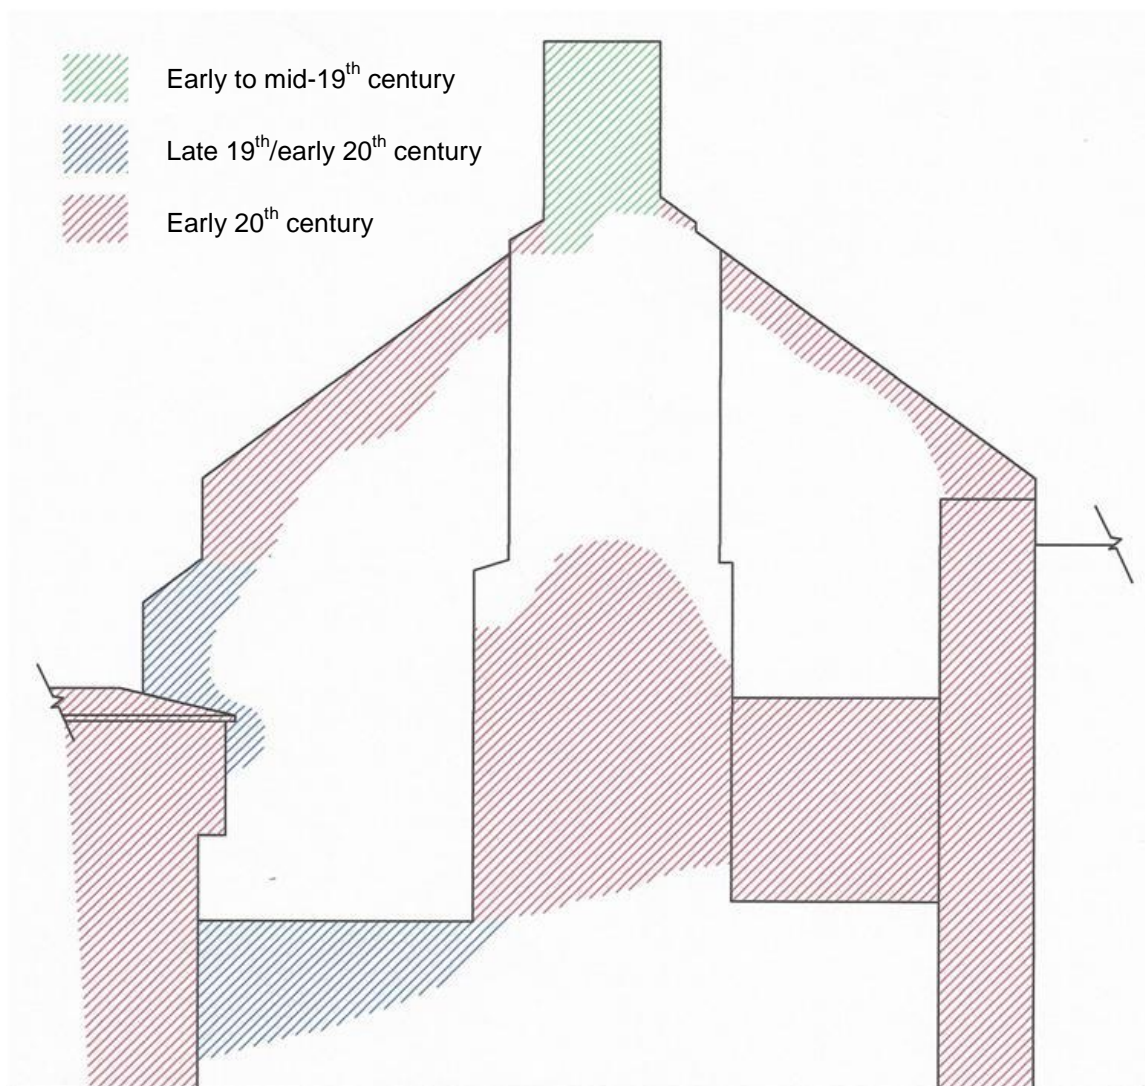
Figure 2: External face of gable wall

This diagram shows a number of separate alterations. Those that run across the top of the building, just below the roof, indicate the alterations made when the house was rebuilt in 1908. The chimney rising above this is in brown brick and seems to date from an earlier period. Along the right-hand side the corner of the previous building has been clad in brick and stone, as noted above. At the left-hand side the boundary wall abuts the gable. The three alterations at and below the mid-point of the gable represent the insertion of the fireplaces into the house in 1908 and the 1930s. This necessitated opening up the gable and adding new masonry to house the flues as they turn towards the chimneybreast in the centre of the facade.

The unknown factor in this is the original chimneybreast and chimney stack. There is no hearth on this gable wall in the house that is as early as this chimney stack, which may be as early as the late eighteenth century. It is possible that this chimney relates to the building that stood on the car park site and not to the house at all.

The stonework that is not coloured in this diagram, and which forms part of the earlier gable wall, contains some fragments of brick and hence cannot be medieval. It seems probable that this wall dates from the eighteenth century, as indicated by the significant amounts of brick, particularly in the two corners of the wall.
