Woodstock House

CONSERVATION & DEVELOPMENT FEBRUARY 2006

PAUL ARNOLD ARCHITECTS
38 Lennox Street, Portobello, D8
tel.01 475 0900, fax.01 478 9979, e-mail. paarnold@indigo.ie

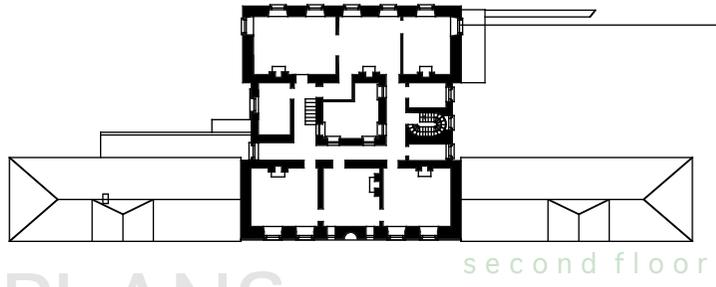
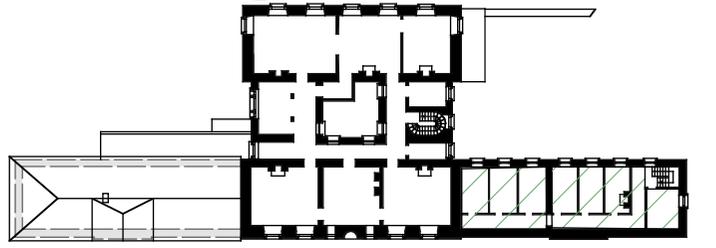
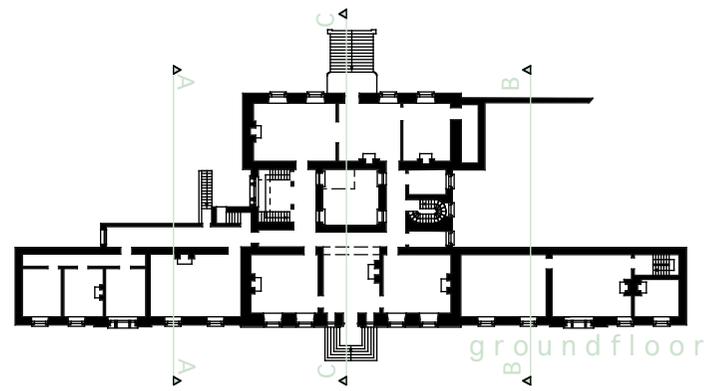
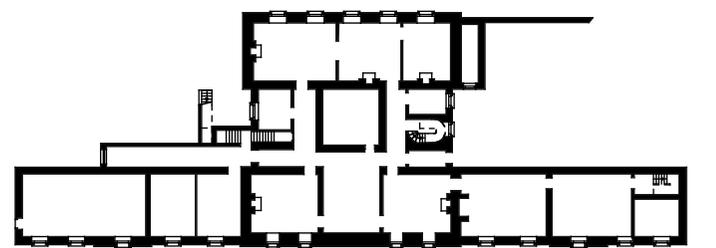
PLANS

The internal house walls were composed entirely of brick, and the arrangement of rooms is based on a spine plan with the main chimney walls running parallel to the façade and garden elevations. An unusual feature is a square light well in the middle of the house. The main staircase which flanked the east side of the light well, was an open well staircase, lit by a large tripartite window on the east elevation. The servants staircase lay on the west side of the light well, and was a cantilevered spiral staircase.

The ground floor rooms to the front retained their original 1740's features, while those rooms overlooking the Winter Garden on the garden elevation, were all altered during the 19th century, with one of the windows transformed into a French door in the 1850's when the Turner staircase was added. Bedrooms occupied most of the rooms

on the first and second floors. The basement of the main block was vaulted throughout in brick.

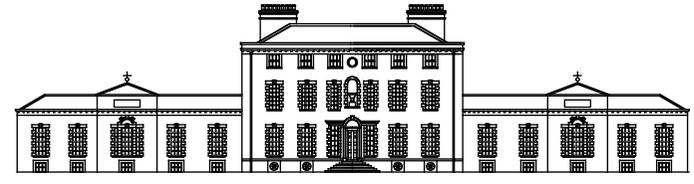
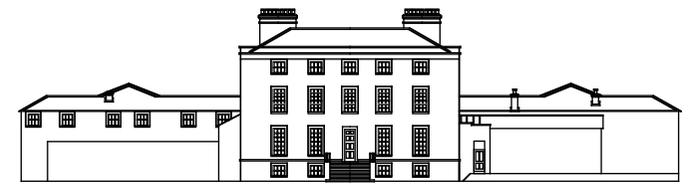
ELEVATIONS

The main block is a seven-bay three-storey over-raised basement structure, on a square plan, facing north. The limestone roof parapet has moulded cornices, and an original placement of drainpipes set inside the ashlar quoins. The walls are rubble stone, rendered externally and lined internally with brick. The entrance is formed by creating a group of the round-headed entrance opening and square-headed flanking windows. The lunette over the entrance opening rests on scrolled consoles, and has a large scroll in place of a keystone. Above the entrance is a niche, which contained a classical figure, this was subsequently replaced c.1900 by an urn, which remained in place until the 1960's. Above this niche is an oculus.

The garden elevation is more simply decorated, and like the façade it is three-storeys over-raised basement, but has five bays. As the façade, there is a limestone roof parapet and ashlar quoins. The

window openings are square-headed, with plain limestone surrounds, blocked keystones to the ground and first floors, and simple keystones to the basement and second floor. The basement is surmounted by a projecting limestone cornice, and has had its windows blocked. The central window of the ground floor of the garden elevation was altered during the 1850's to allow access to the garden below, via a wide iron staircase designed by Richard Turner.

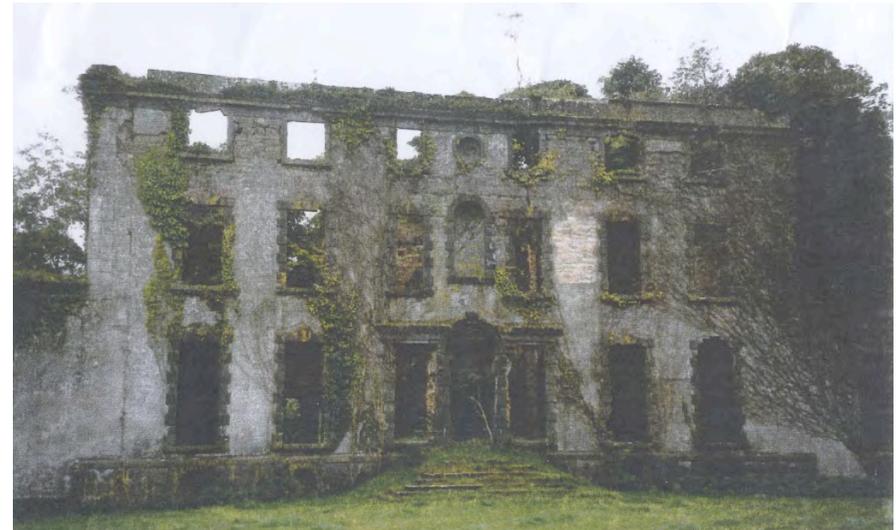
4. View of Woodstock in 2000

The fire of 1922 ravaged the main block of Woodstock destroying the roofs, windows and doors as well as all of the remaining contents. The fire however left the east and west wings intact enough to allow habitation until the 1940's. The entire house is now derelict, and covered with a considerable amount of vegetation. Although an effort was made to remove the vegetation in 1998, it has grown back, since when the house appears to have deteriorated.

The front elevation has much dilapidation and distortion of the walls and entrance opening, with the collapse of the central part of the front façade in March 2001 during a storm. Many of the window heads on the second floor have been lost or irreparably damaged, along with much of the roof parapet and its upper cornice. A skeleton support structure has been put in place at the front façade to limit further loss of fabric.

Generally the garden elevation appears to be in a more intact state than the front elevation, although the window heads are similarly damaged, and the upper part of the roof parapet has been lost. The blocking up of the windows to the basement dates from a period after the fire.

The limestone surrounds to openings have fire damage: in order to achieve structural integrity, these should be repaired. It will be important to archaeologically sift through the debris so as to record as much as possible of the remaining fabric, as was done at Powerscourt and Uppark: such work would be of enormous importance in the event of a restoration.

The overall structural condition of the building will require detailed analysis, based on detailed measured drawings, sectional analysis, foundation analysis in the context of proposed new uses.

In the short term, it is urgent that tops of walls be protected, and that a system of minimizing further water ingress be put in place.

Vegetation should be controlled. Access to the ruin should continue to be controlled.

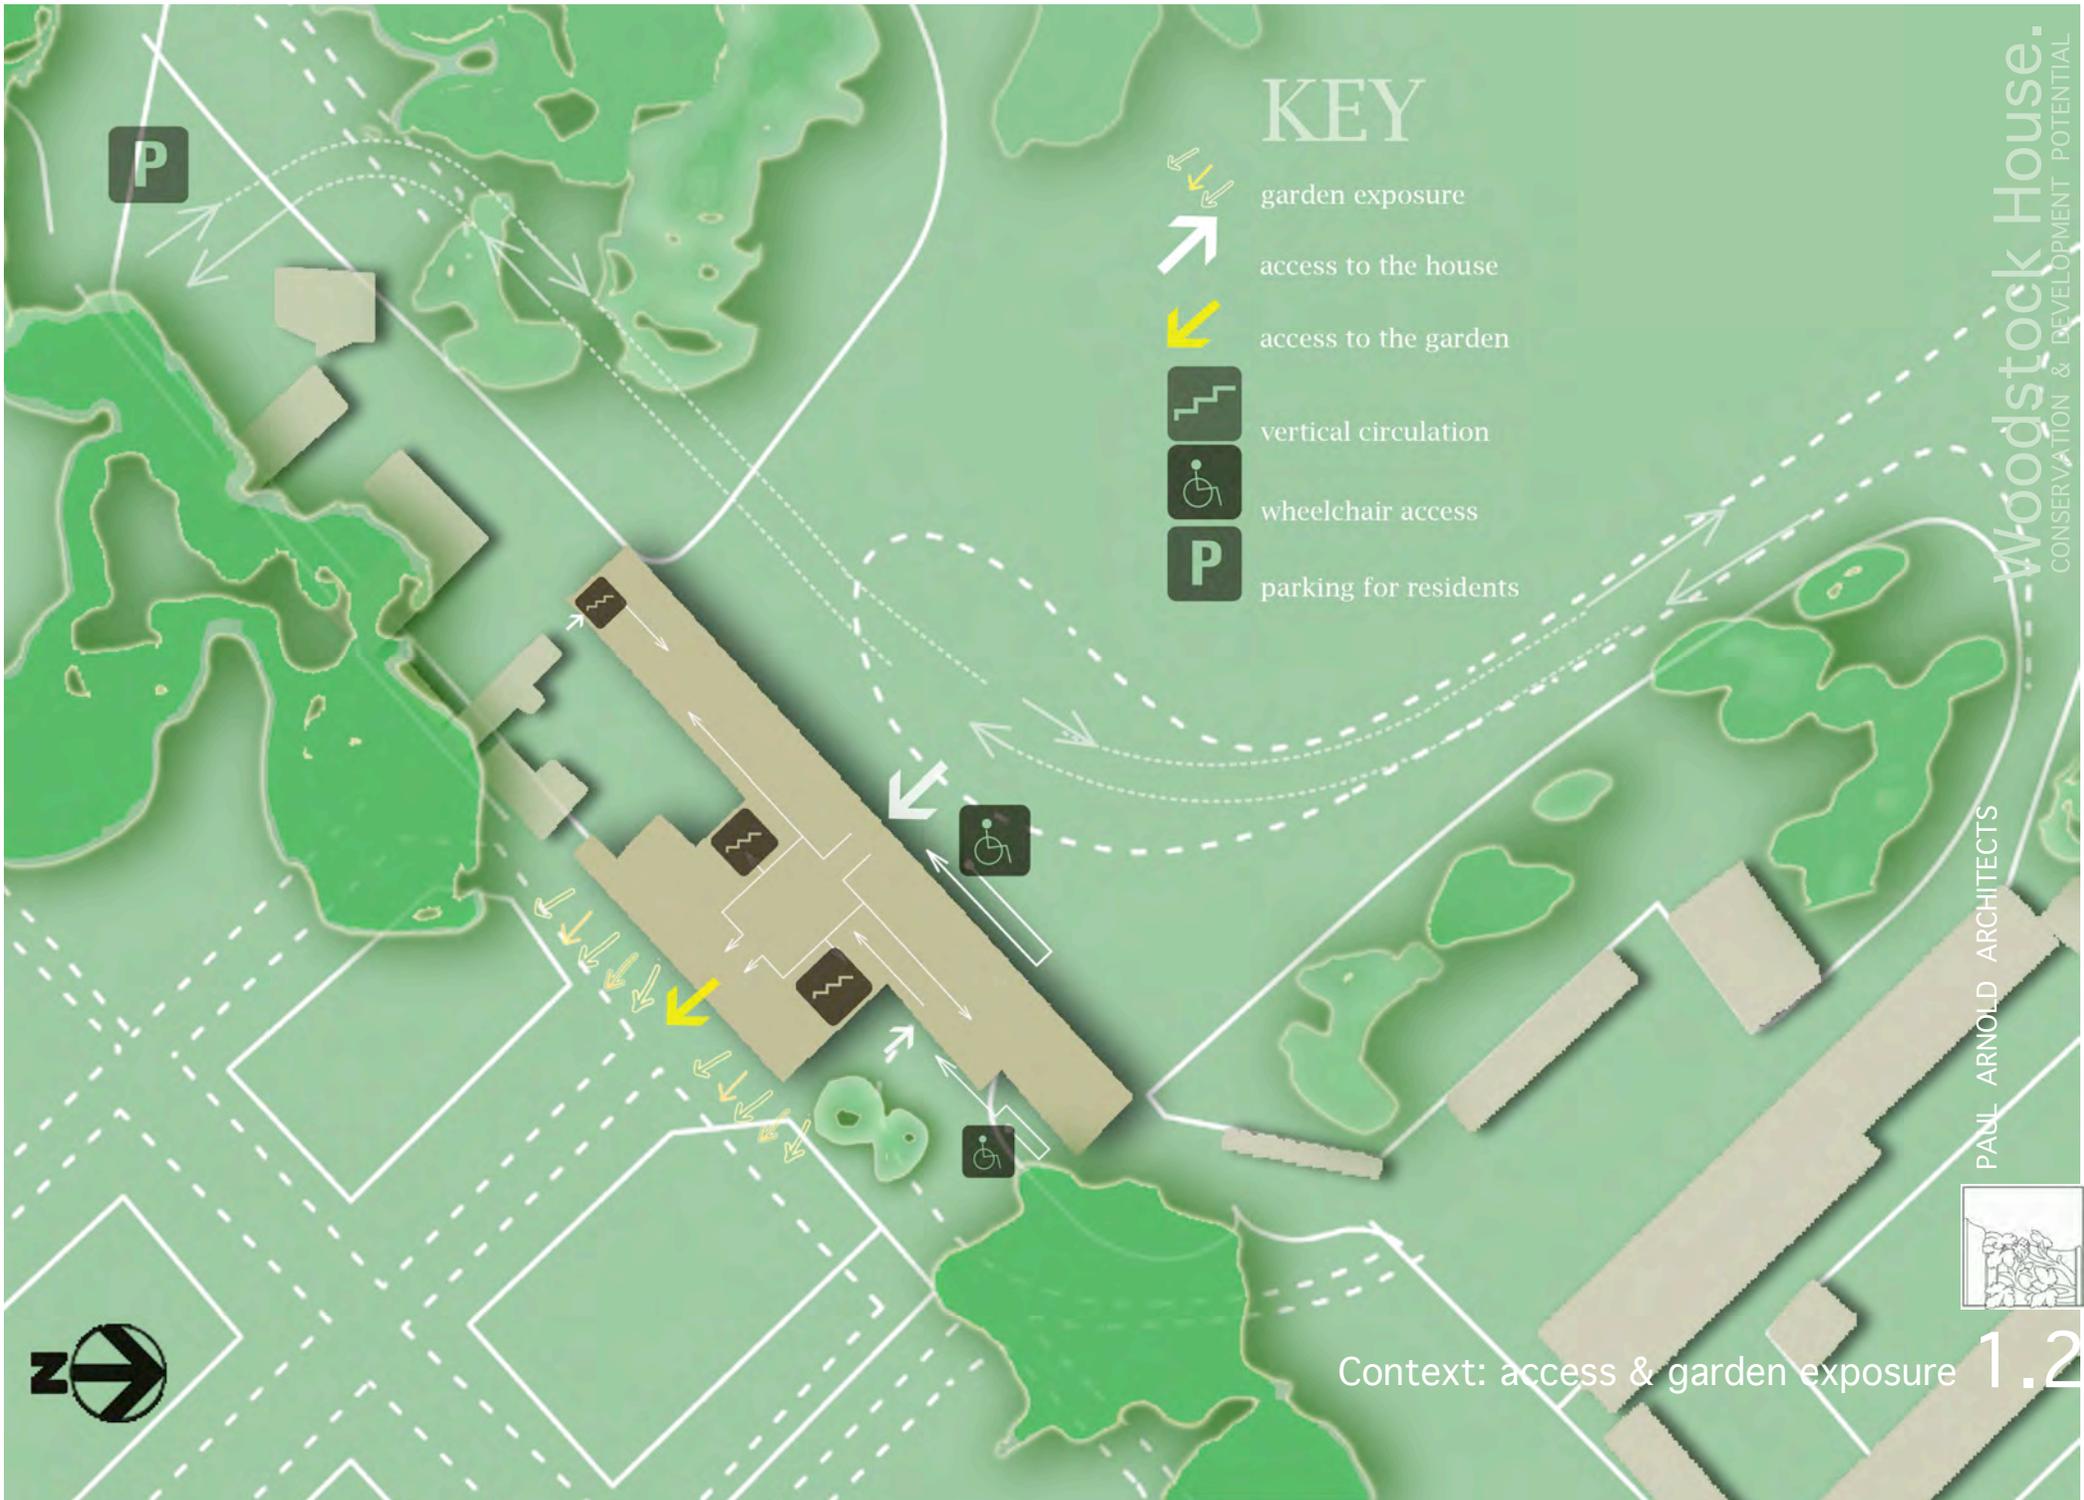
Context: access & garden exposure 1.2

The Public areas in all illustrated schemes allow visitors to approach the estate from the historic main entrance: I understand that new visitor parking is also to be provided on this side: parking for residents is indicated adjacent to the house.

It should be possible to achieve access by wheelchair from a new ramp at the main entrance.

Visitors will be brought into the house and will be able to overlook the as-yet-to-be -reconstructed parterres, as they were intended to be overlooked originally. It may be desirable to reconstruct the main livingroom.

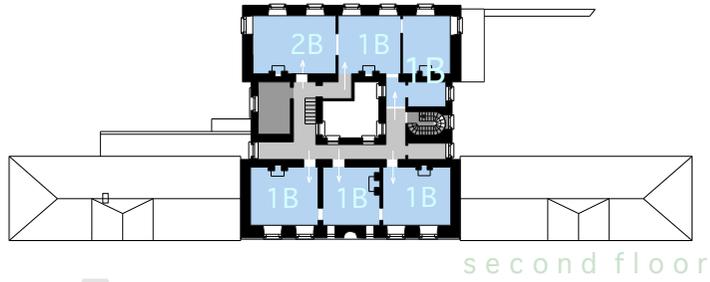
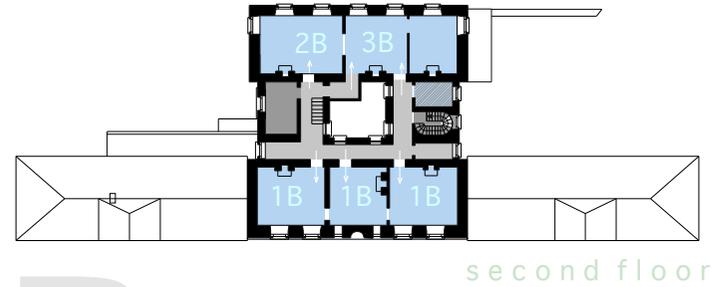
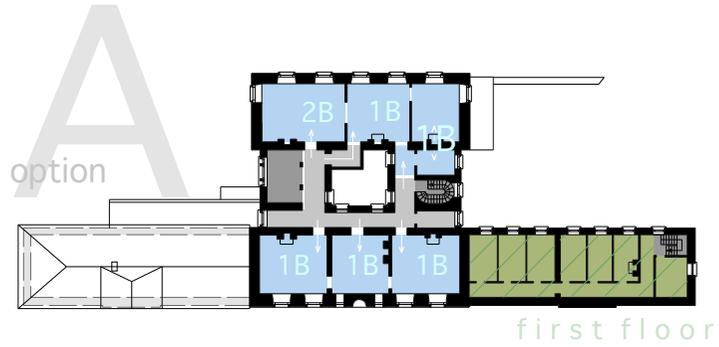
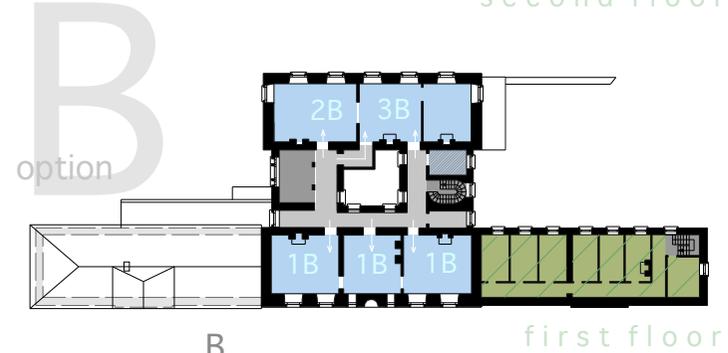
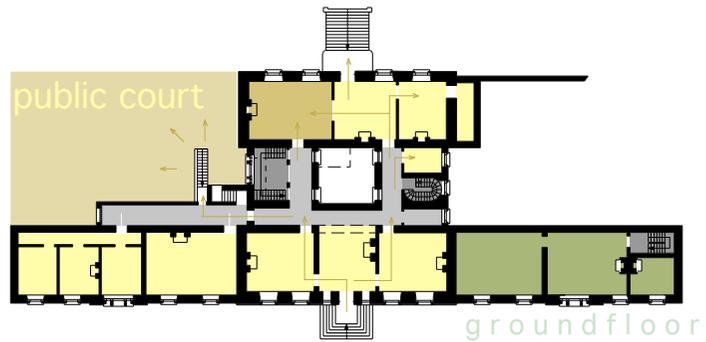
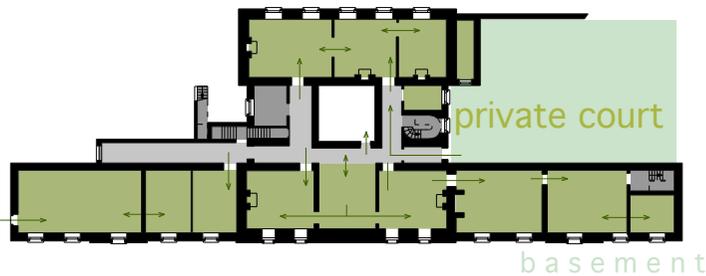
In this scheme between 512 and 548 sq metres of residential development is located on the upper floors, with public use for the ground floor of 377 sq m and civic use of 737 sq m at basement and ground floor level in the main house and wings.

A	548 sqm	RESIDENTIAL	512 sqm
A	1B: 10 apartments (38 - 52 sqm each)		
A	2B: 2 apartments (55 sqm each)		
A	3B: none		
B	1B: 6 apartments (38 - 45sqm each)		
B	2B: 2 apartments (55 sqm each)		
B	3B: 2 apartments (73 sqm each)		
	377 sqm	PUBLIC	377 sqm
	737 sqm	CIVIC	737 sqm
	182 sqm	VERTICAL CIRCULATION	182 sqm
	378 sqm	HORIZONTAL CIRCULATION	390 sqm

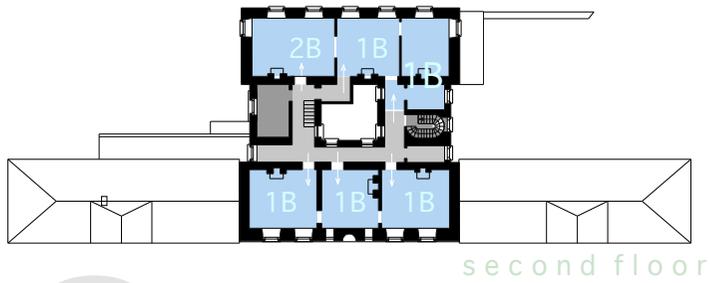
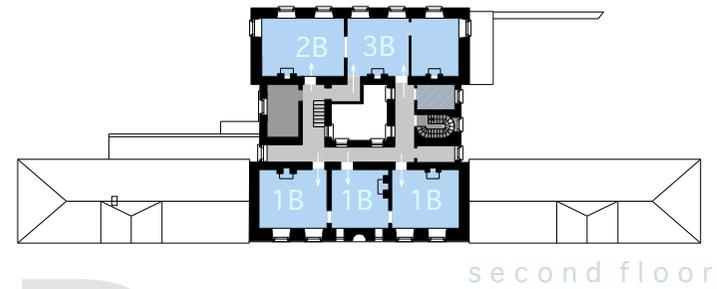
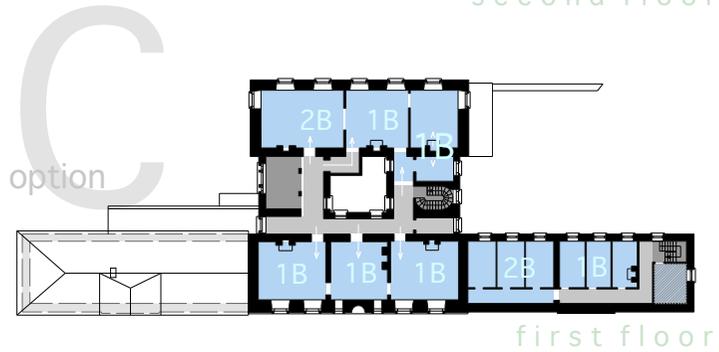
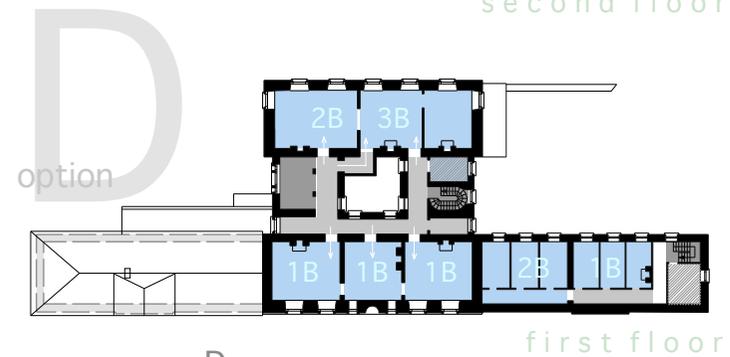
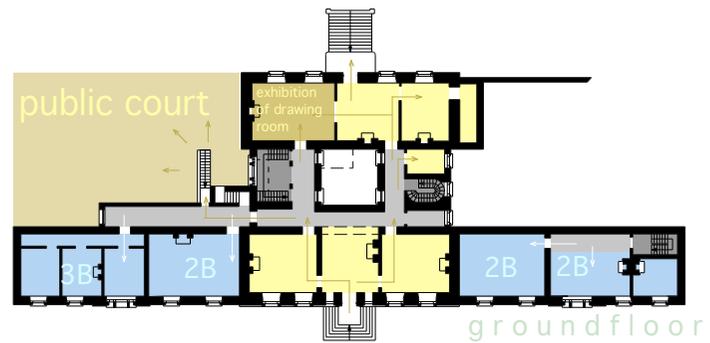
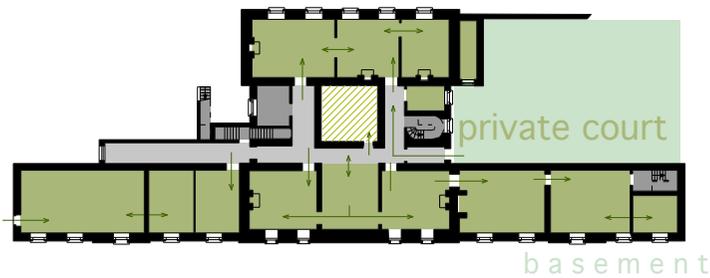
Residential development of between 887 and 923 sq m, with public use of 284 and civic use of 595 sq m.

C	923 sqm RESIDENTIAL	887 sqm
C	1B: 11 apartments (38 - 52 sqm each)	
	2B: 6 apartments (55 - 61 sqm each)	
	3B: 1 apartment (80sqm)	
D	1B: 7 apartments (38 - 52 sqm each)	
	2B: 6 apartments (55 - 61 sqm each)	
	3B: 3 apartments (73 - 88 sqm each)	
	284 sqm PUBLIC	284 sqm
	595 sqm CIVIC	595 sqm
	182 sqm VERTICAL CIRCULATION	182 sqm
	394 sqm HORIZONTAL CIRCULATION	406 sqm

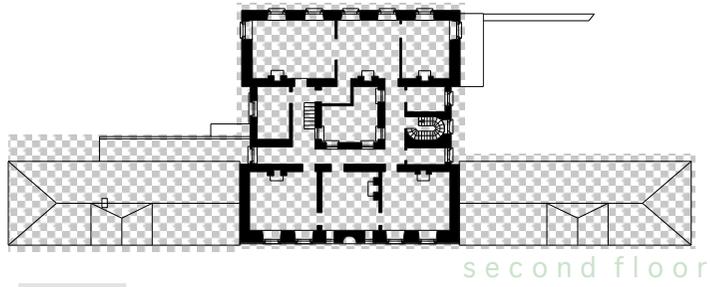
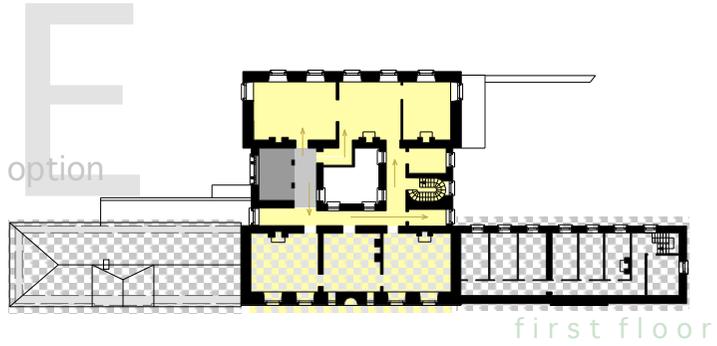
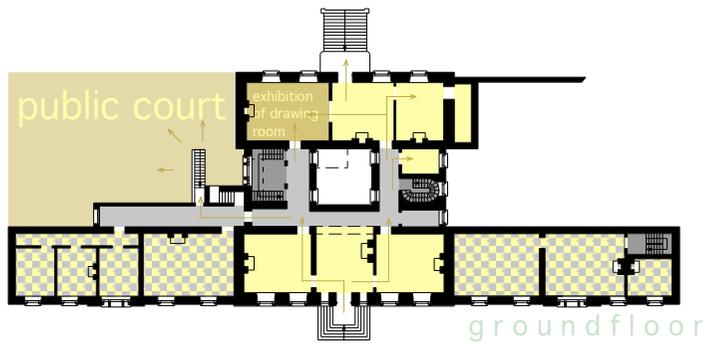
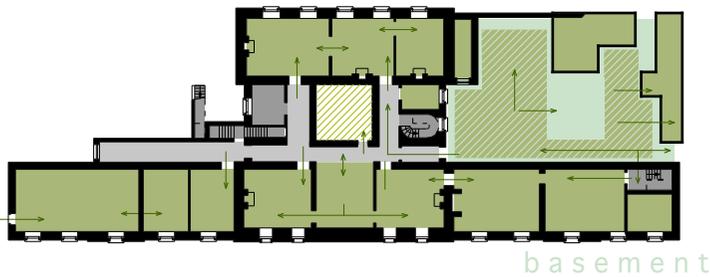
The use of space 2.3

This scheme shows no residential use, with public (516 sq m) and civic (690 sq m) use shown on the basement, ground and first floors, within the shell of the house.

RUINS	
RUINS accessible to public	
PUBLIC	516 sqm
CIVIC	690 sqm
CIVIC-additional space by including the yard	220 sqm
HORIZONTAL CIRCULATION	213 sqm
VERTICAL CIRCULATION	145 sqm

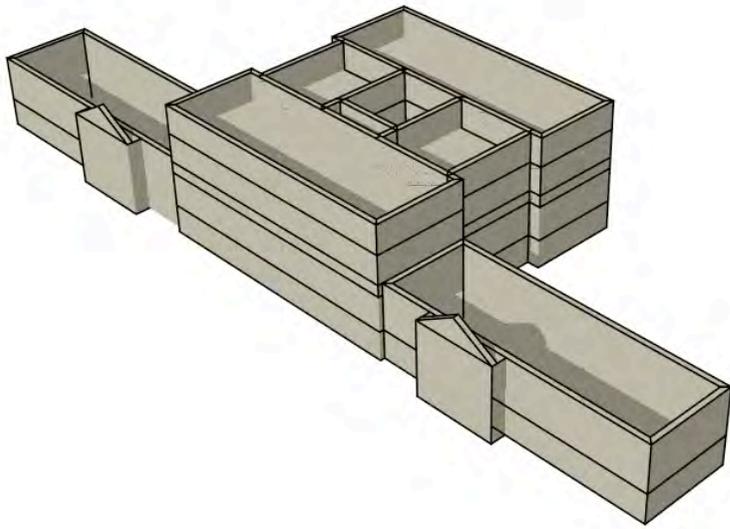
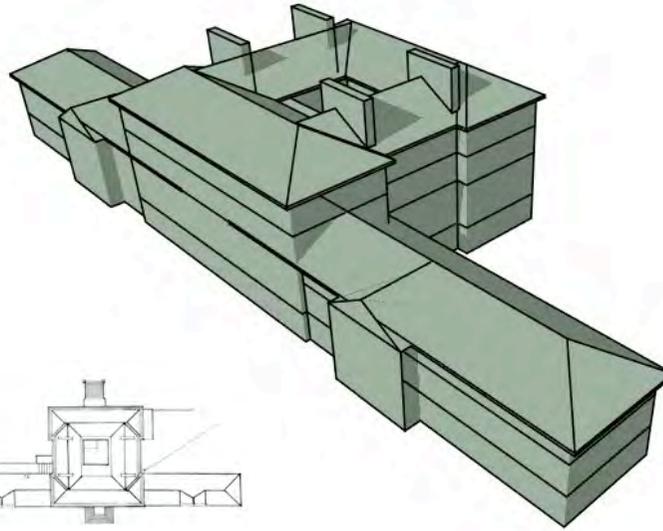
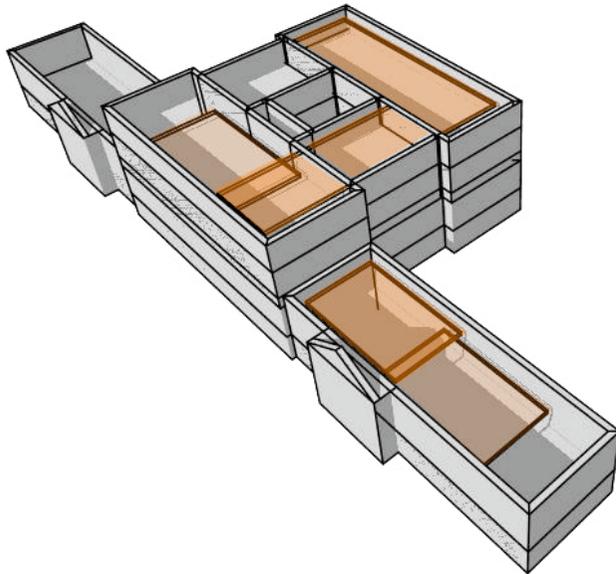
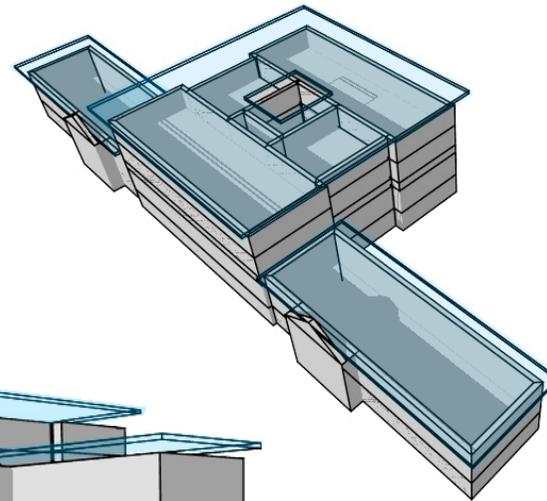
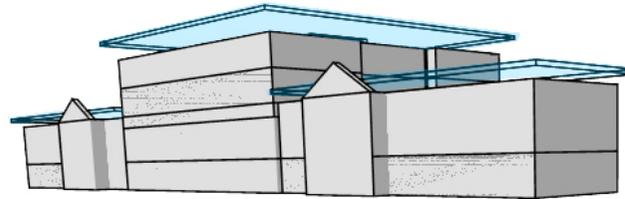
Treatment 3.1

This drawing indicates the ruins consolidated, with no use of the enclosed spaces envisaged.

The necessary works of consolidation will include structural work to complete the main façade and such related internal walls as are necessary for stability, dismantling and reconstruction of portions of other walling, capping of walls with lead, and possible provision of an impermeable layer over the remaining basement vaults to minimize water ingress.

This drawing indicates possible architectural treatment of the ruins.

It would be possible to reinstate the exterior of the building complete with chimneys, pitched roofs and windows. This would help to ensure the survival of the masonry, but importantly the house would have an improved presence and enhance the demesne.

Drawing 3.1.C Floating Roof: Alternatively, a roof could be designed to oversail the extant ruins.

Drawing 3.1.D Roof Within Ruins: It would be possible to inhabit the ruins keeping development below the tops of walls and using only such space as is desired.
