# ABBEY QUARTER MASTERPLAN AREA ARCHAEOLOGICAL STRATEGY

KILKENNY COUNTY COUNCIL

COURTNEY DEERY HERITAGE CONSULTANCY LTD

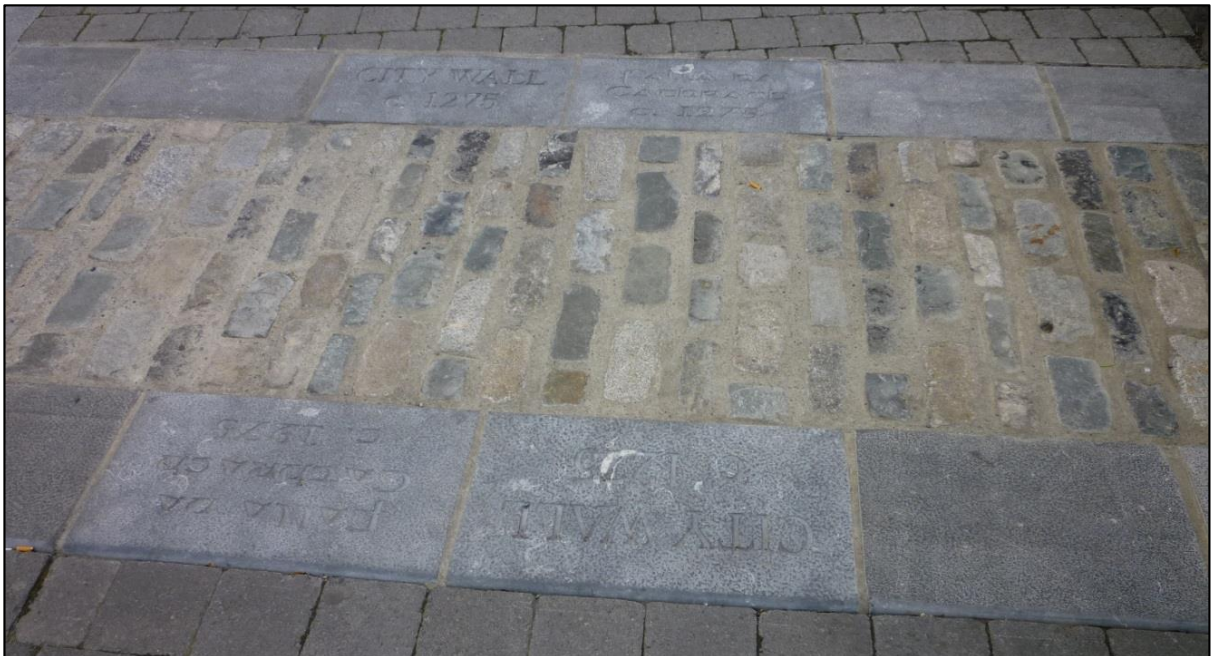
*Plate 1 Presentation of the City Wall at Watergate*

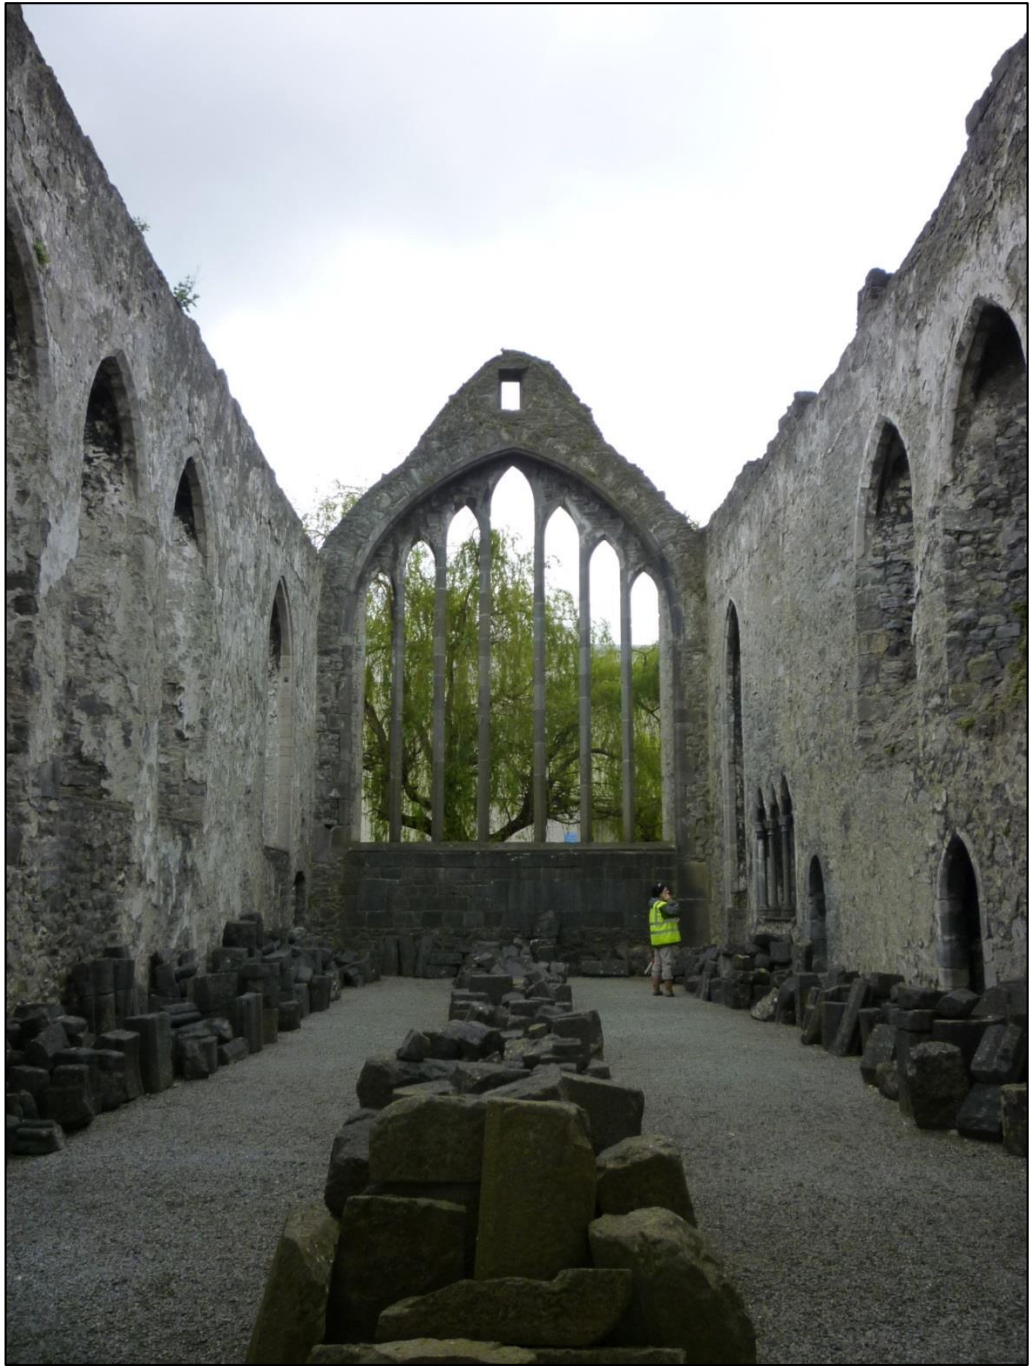
*Plate 2 East Window of St Francis' Abbey*

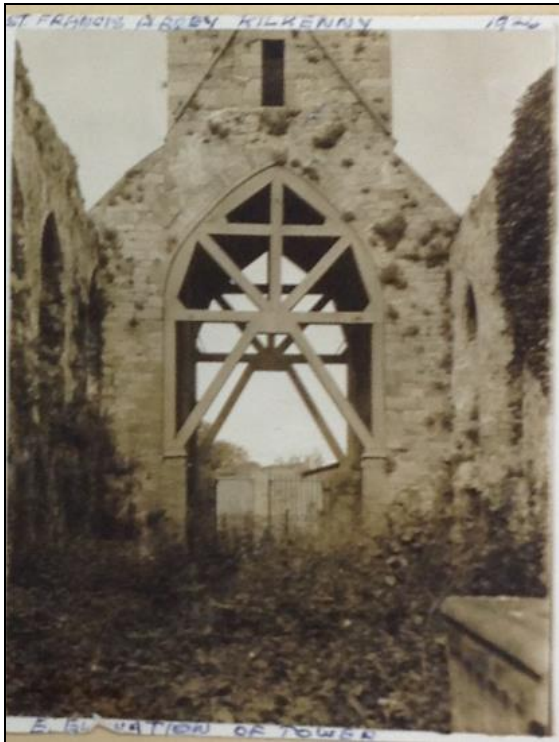
Plate 5 Eastern Elevation of Tower 1926

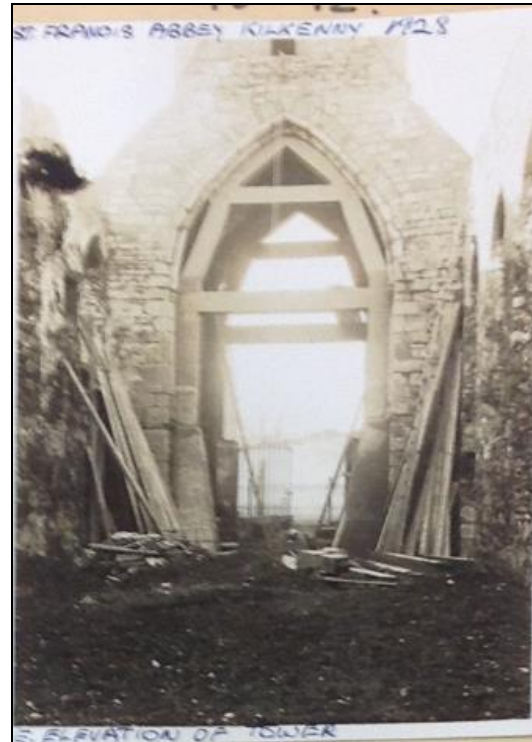
Plate 6 Eastern Elevation of Tower 1928

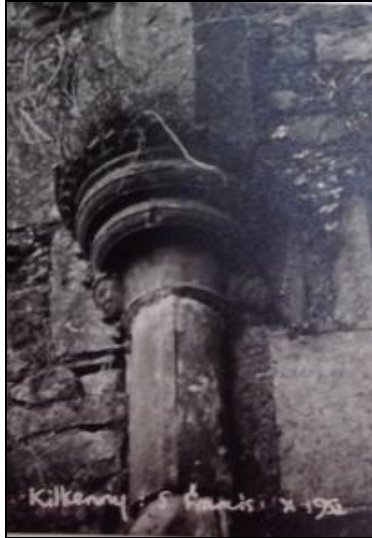
Plate 7 Detail of stone work 1952

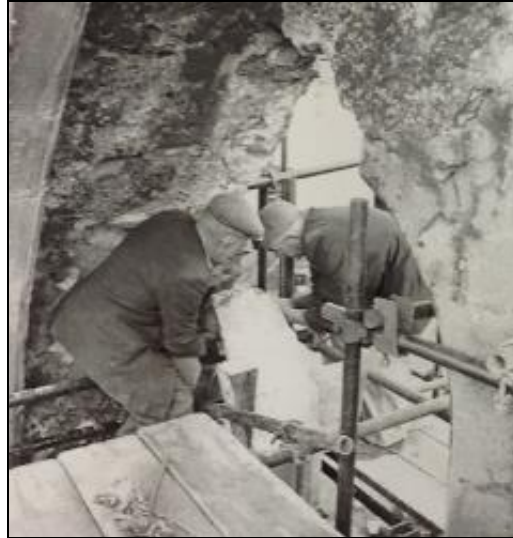
Plate 8 Stone masons at work St Francis' Abbey

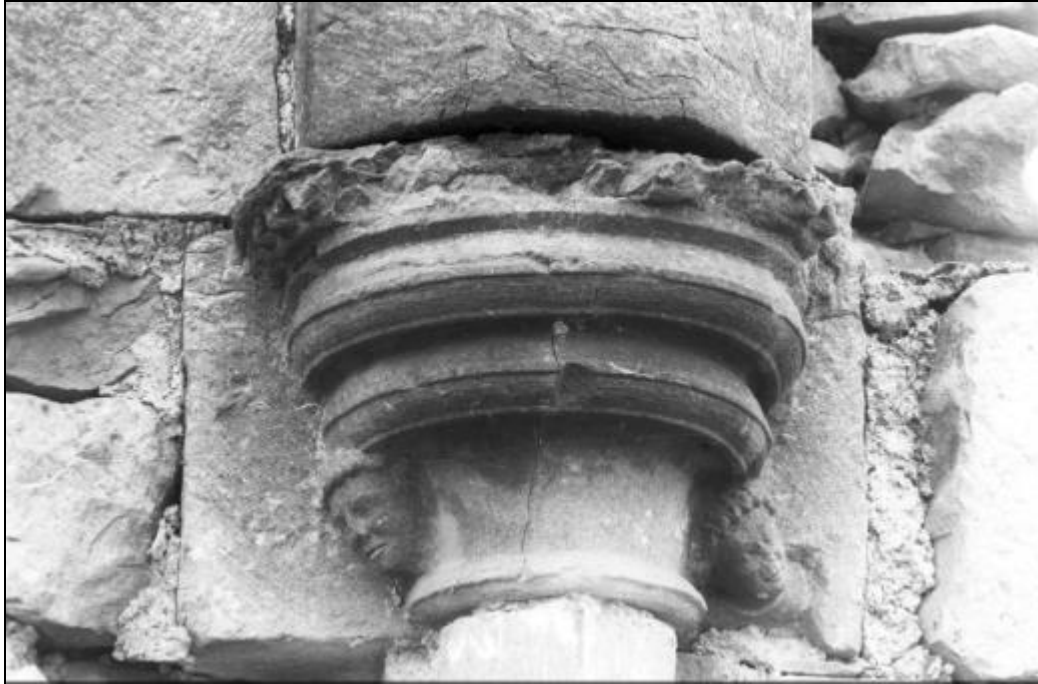
Plate 10, *The Stalley Collection*, Bell capital with dogtooth on (damaged) abacus and head carvings to left and right of shaft, [www.gothicpast.com](http://www.gothicpast.com)

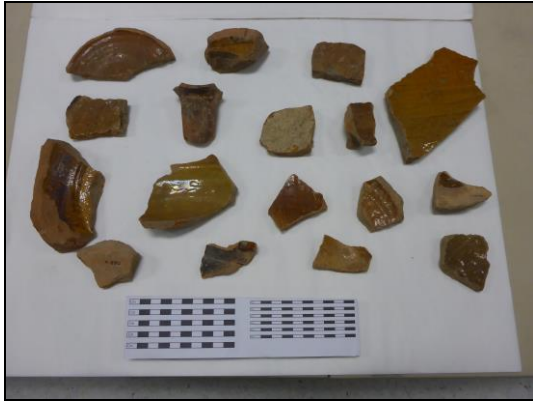
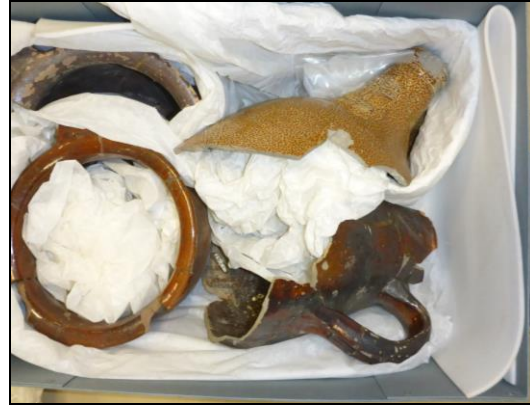
Plate 11: A sample 17<sup>th</sup> century pottery      Plate 12: E0096 Reconstructed Pots

A further twelve boxes containing floor tiles, medieval pottery and modern pottery were reviewed and photographed. These finds had been sorted and prefaced with the No. 4 and then the find number. No metal finds were retrieved and only one loose vertebra (possible human) with no identification tag was noted within these finds, no further skeletal remains were uncovered.

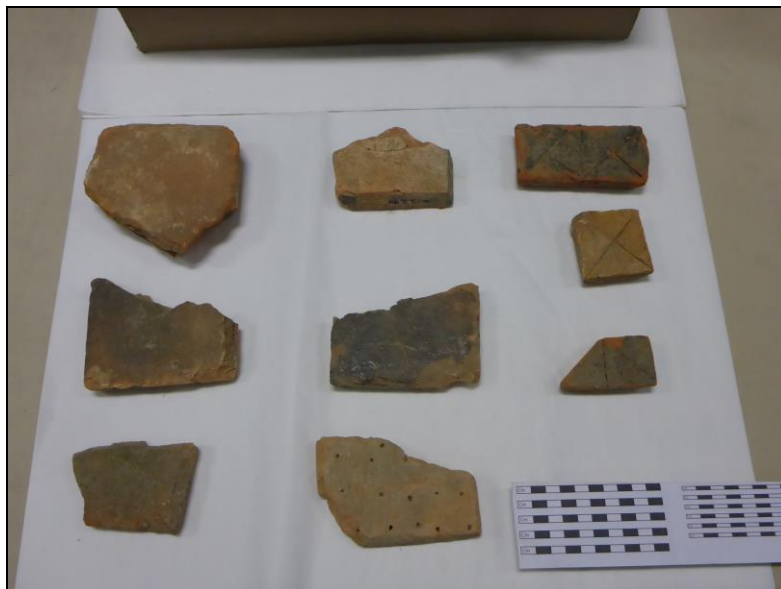
Plate 13: A sample of the floor tiles

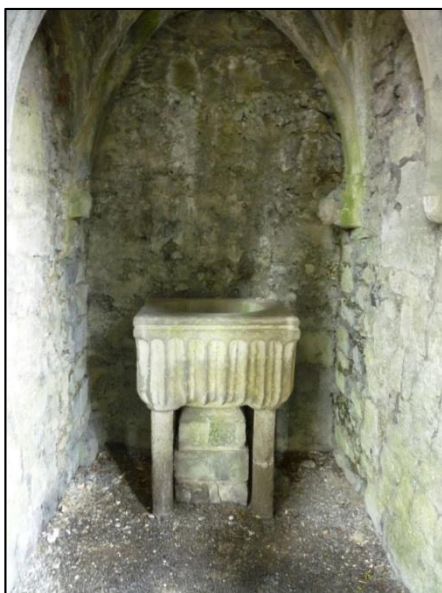
Plate 17 St Ciaran's Font, St Francis' Abbey

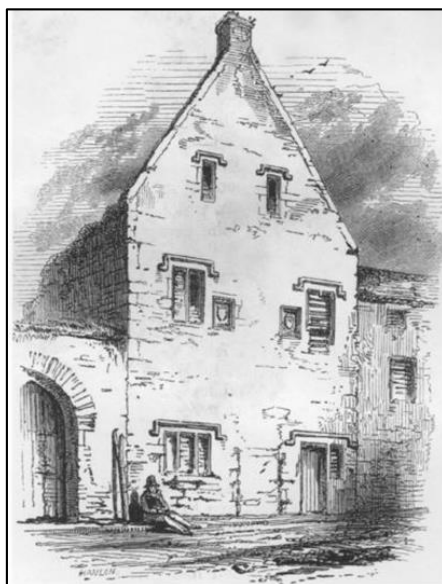
*Plate 18 Bull Inn, Kilkenny by Reverend James Graves, 1841 (reproduced from JRSAI, 1862-63)*

Prim<sup>72</sup> suggests that the 'Bull Inn' may have been the first inn or 'place of call' established in Irishtown, Kilkenny, although there probably were older inns in Englishtown, Kilkenny. The 'Bull Inn' is located on the south side of St Canice's Place (formerly known as Bull Alley). This was a three-storey gable-fronted stone building, the apex of which was surmounted by a stone chimney. An illustration by Reverend James Graves in 1841, published in JRSAI (1862-63) and said to be an accurate sketch (Plate 18)<sup>73</sup>, indicates a window and off-centre door on the ground floor, two windows on the second storey and two small windows on the third storey. The windows on the ground floor and the second story are divided by mullions and all the opes have hood-mouldings. There is a discrepancy between this drawing and Prim's description of the opes on the ground floor, with Prim describing a central door at ground level and a window on each side. It is possible that Prim's description describes the building as it was originally built, and that the 1841 drawing represents later changes to the door and window, as Prim does make reference to modern alterations to the door. Prim also tells us that the stone framed windows in the rear of the building were all extremely small in the ground floor, but the stories above had high, narrow slit-like windows, similar to, but not quite as large as the two uppermost windows in the gable fronting the street. The 1841 drawing depicts the building as unroofed.

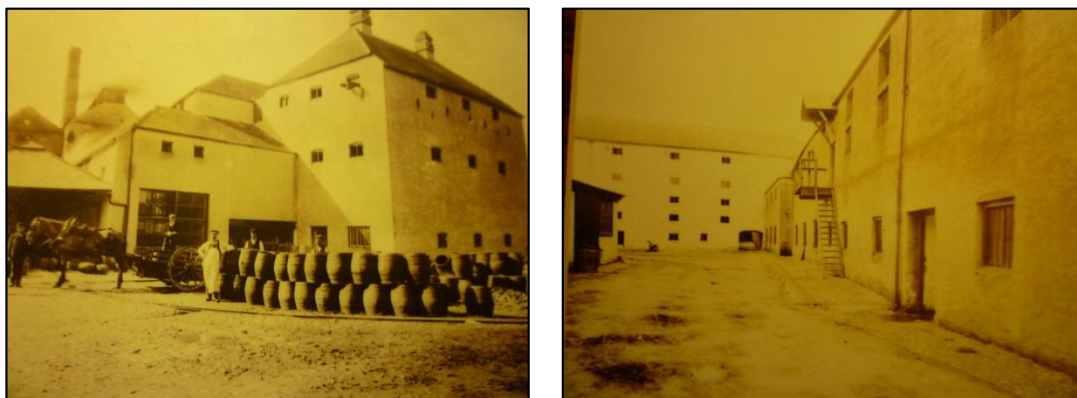
*Plates 21 and 22 Showing St Francis' Abbey Brewery late 19<sup>th</sup> century*

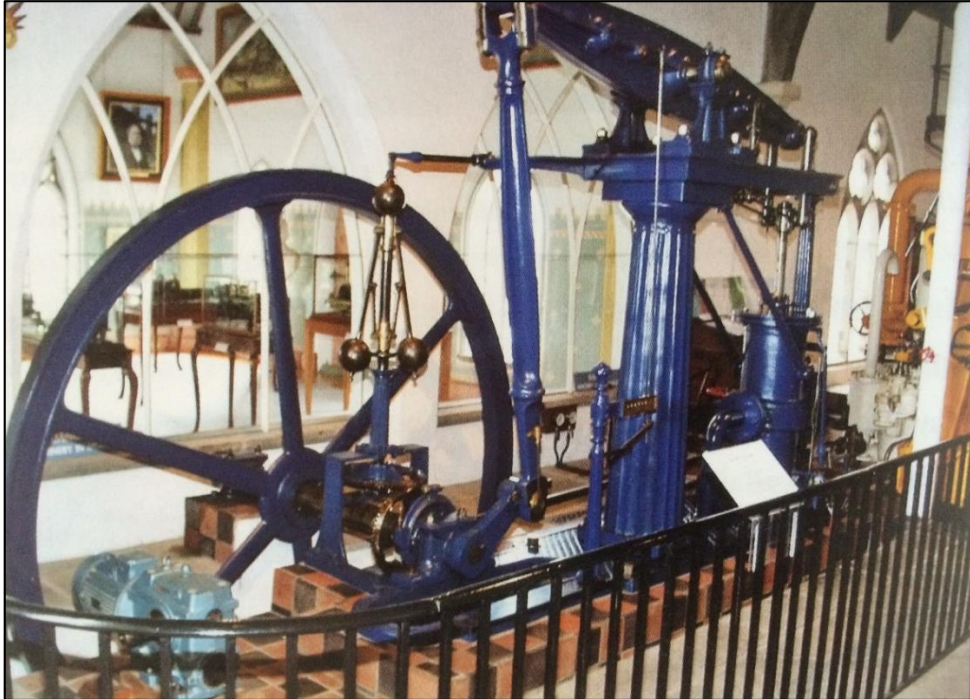
*Plate 23 Single-column beam engine*

It was during this time that investment took place at the site and a small, single beam engine, reputedly bought by William Smithwick in 1847 at the Manchester Exhibition was installed in the St Francis' Abbey Brewery, where it was worked up until about 1930. The engine is now maintained as a working exhibit at the Steam Museum at Straffan, Co Kildare (Plate 23).

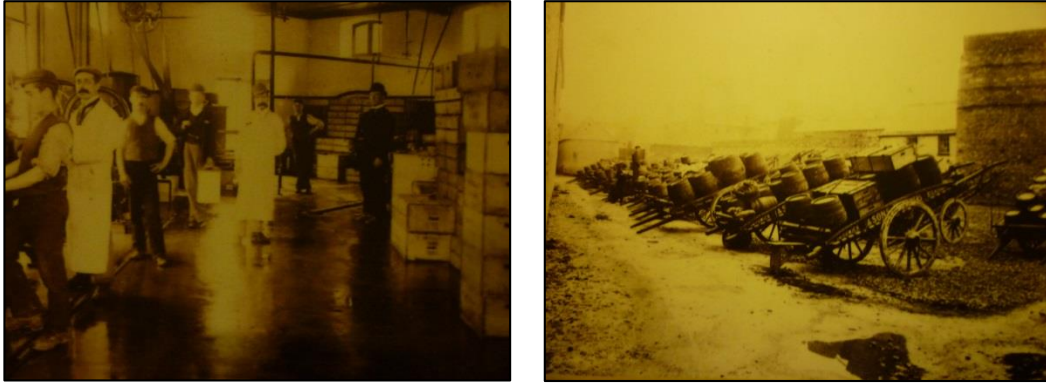
*Plates 24 and 25 St Francis' Abbey Brewery c. 1900's*

St Francis' Brewery continued to grow throughout the 20<sup>th</sup> century and from 1944 onwards the brewery distributed its beer on a national scale (Plates 24 and 25).

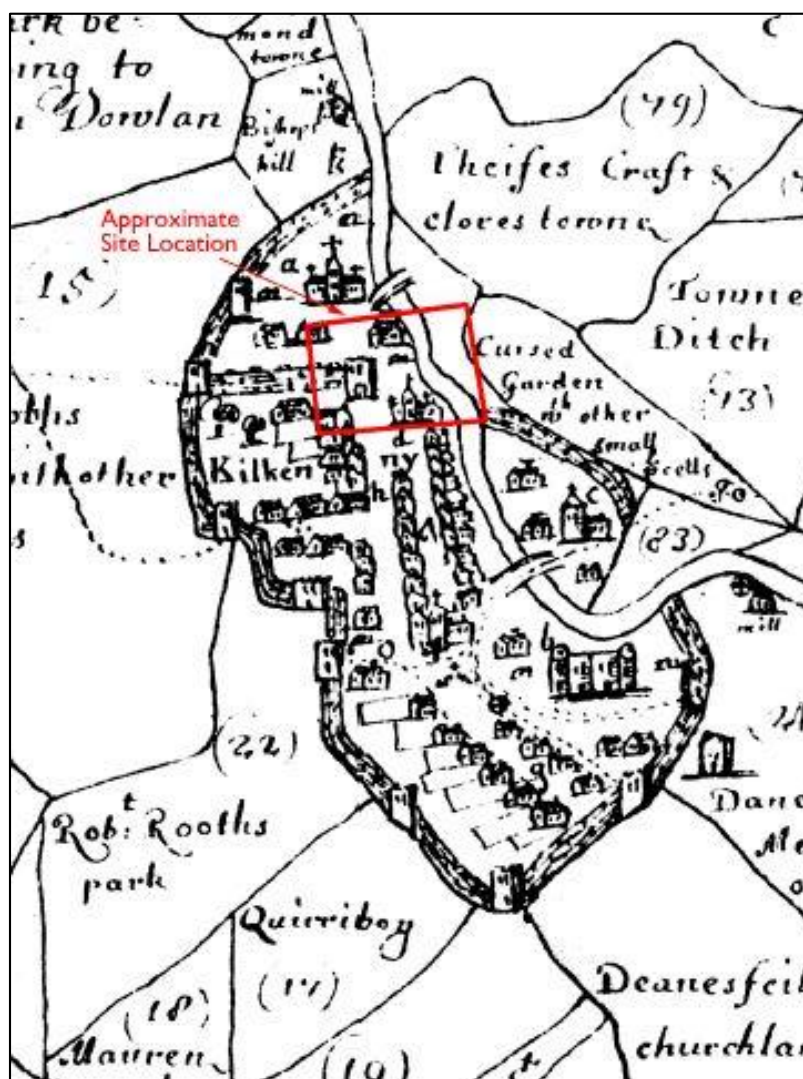
Figure 7 Down Survey c. 1656

The earliest consulted historical map for Kilkenny City is William Petty's Down Survey map, which dates from c. 1656 and shows the 'Liberties of Kilkenny'. This map indicates the old town walls on both the east and west side of the River Nore, with two bridges crossing the river possibly in the environs of what are now known as John's Bridge and Green's Bridge. The course of the River Breagh is not depicted on the map and while St Francis' Abbey is not named there is a structure that could correspond to the medieval building located on the west bank of the River Nore. It is possible that the abbey is represented by the structure shown to the southeast of Irishtown Gate and an expanse of wall extending westwards which is indicated but not named on the map. A structure located on the western banks of the River Nore to the north of Irishtown Gate could relate to mill structures on the south side of the northernmost bridge, though again they are not named as such.

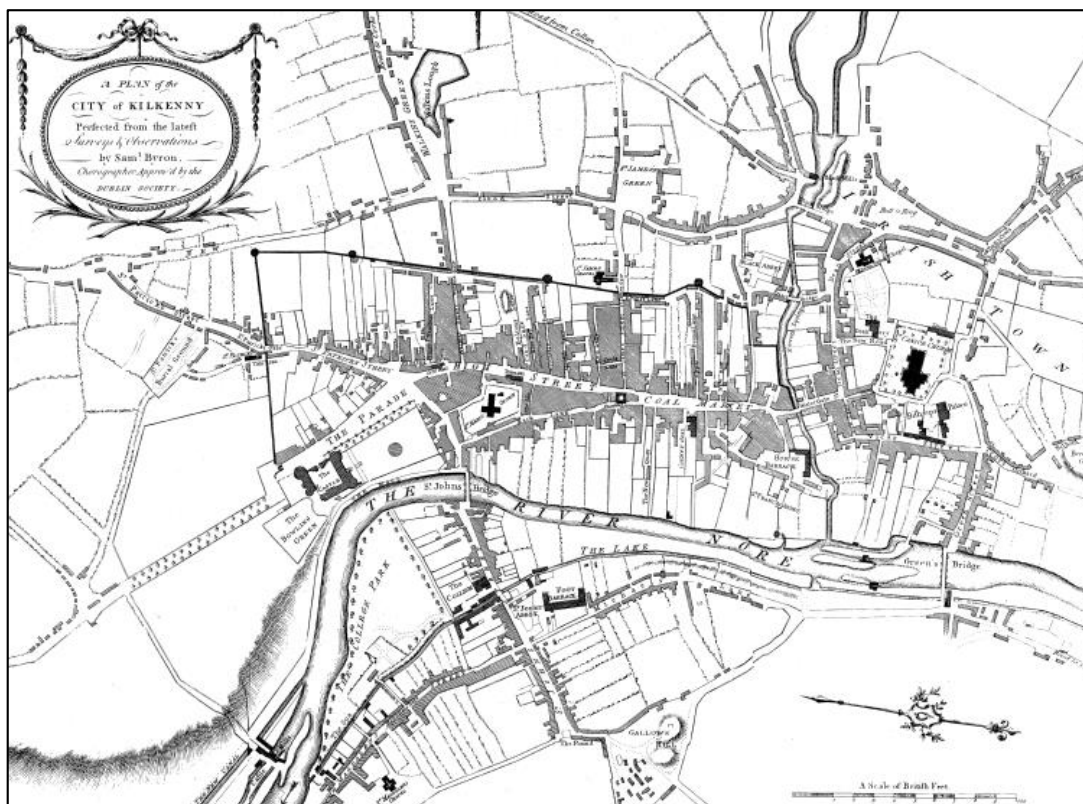
Figure 10 A Plan of the City of Kilkenny, by Sam Byron, c. 1781

This map appears to be very similar to Rocque, key features such as St Francis' Abbey and the Horse Barracks and the County Gaol are all named and annotated on the map.

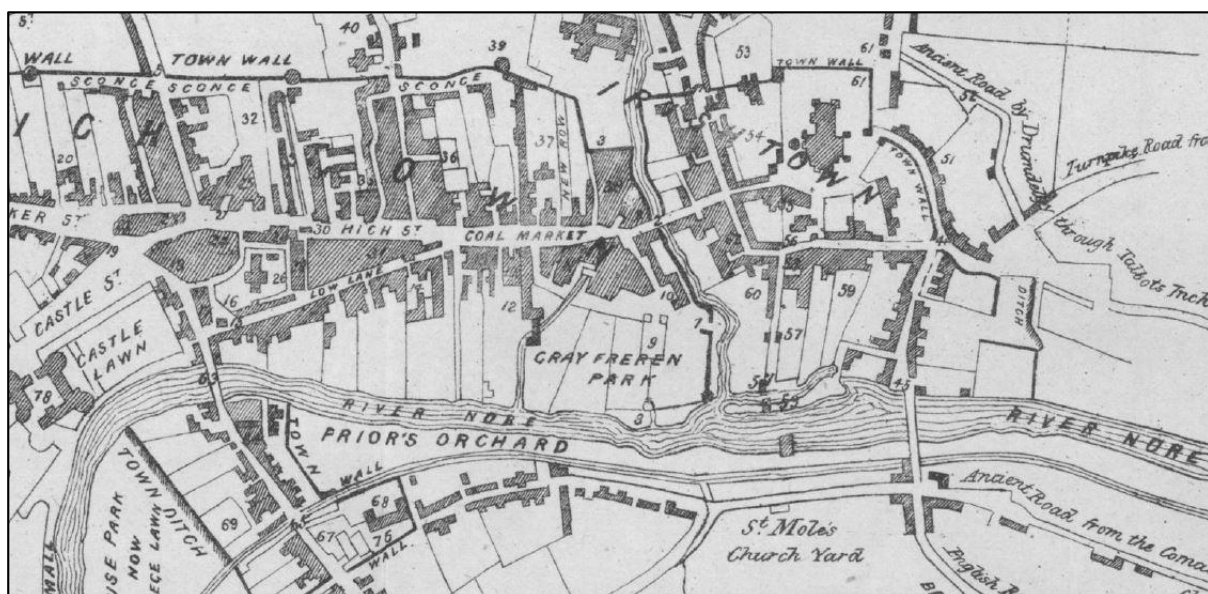
Figure 11 Hogan's map of 1860

62. "The Bull Inn." The large ruined house in Bull-lane.

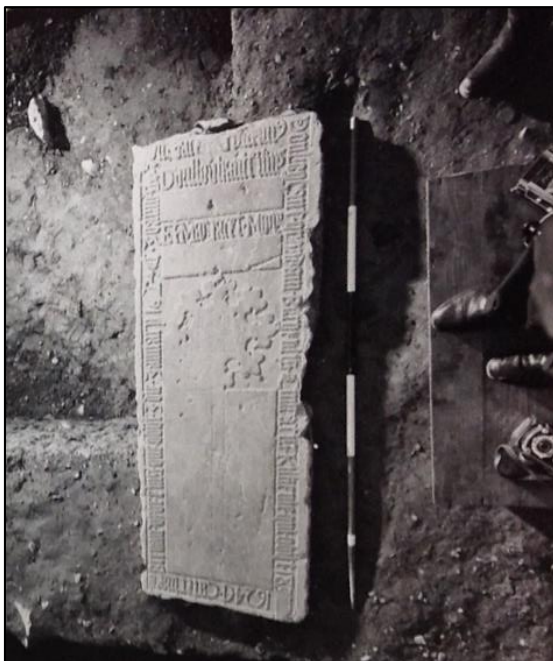
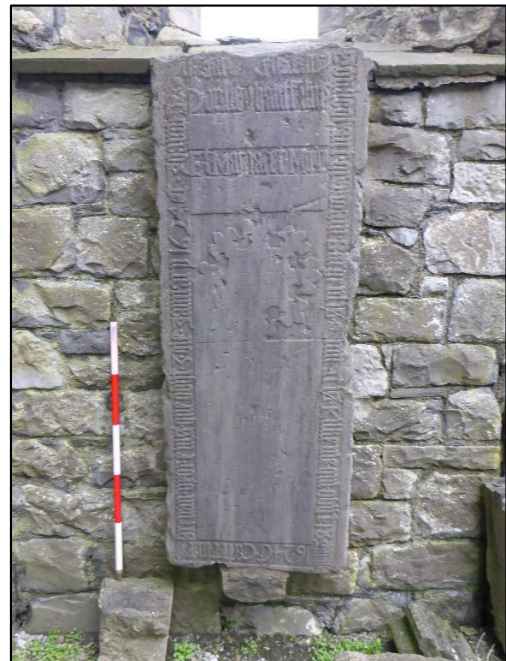
Plates 26 and 27 Photo of Delahunty grave slab as recorded by in situ by Ó hEochaidhe in the 1963 Excavation (on the left) and as existing (on the right).

Archaeological works exposed the foundations of the north aisle of the religious complex dating to the 14th Century, along with those of a substantial transept to its north dating to the 15th/16th Century (Figure 18). Photographic records of the exposure of at least one medieval burial near the transept, along with the discovery in the north transept of the Delahunty grave slab (with Gothic inscription and dated 1624, Plates 26 and 27), indicate the potential for more human remains in the immediate surroundings.

The potential for human remains was verified by Sweetman in the proceeding monitoring briefs of the 1970s. Interestingly, Con Manning, in an article on the Delahunty grave slab in the *Old Kilkenny Review (2007)*, notes that; "burial at the site continued as late as 1687, as shown by a recorded inscription, but may have ceased after 1698, when the site was given over for use as military barracks"<sup>1</sup>.

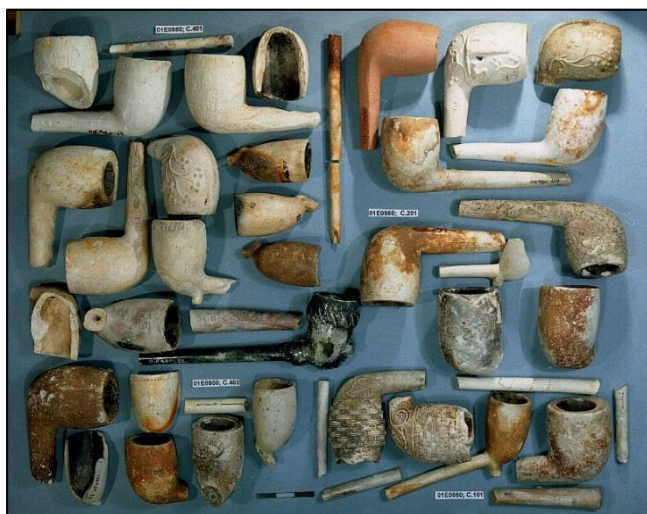
*Plate 28 Collection of clay pipes uncovered during the River Nore Flood Alleviation Scheme (courtesy of Margaret Gowen & Co. Ltd.)*

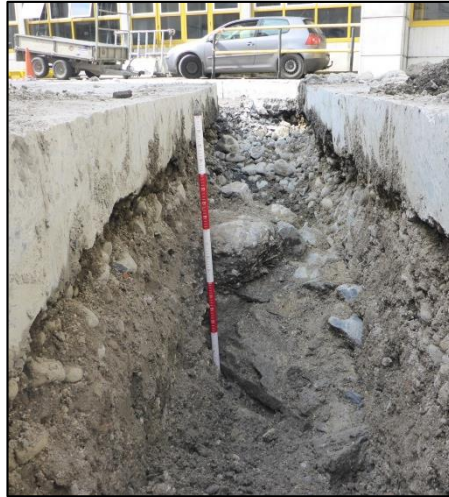
Plate 29 Monitoring ESB trench, culvert section 1

century date. Remnants of a number of walls were identified, many of which appear to correspond with walls depicted on the early OS mapping of the area. Most of the walls were similar in size and construction, and date to the 19<sup>th</sup> century, with possibly one or two walls dating to the 18<sup>th</sup> century. A culvert identified at the north end of section 1 of the trench may relate a structure depicted possibly on Rocque (1758) and on the 1st ed. OS 6-inch map. This culvert may represent the line of an earlier mill stream which issued to the River Nore (Plate 29). The culvert was oriented west-northwest – east-southeast and was constructed of large limestone blocks measuring up to 0.4m x 0.5m. It was present at 0.45m deep, was 1m wide and was cemented in on both sides.

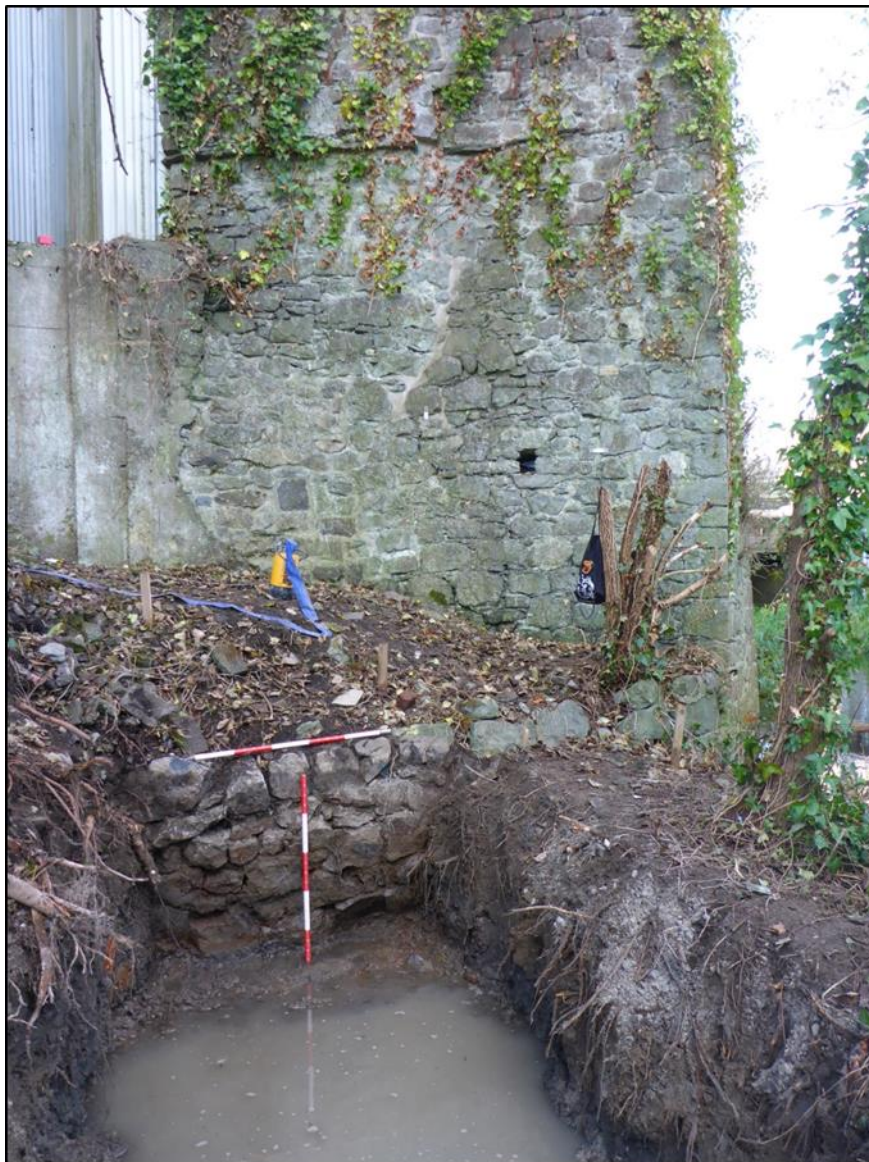
*Plate 31 Revetment wall at Evan's Tower*

Excavation revealed the continuation of a stone wall which adjoined the northeast corner of the tower and was partly visible prior to excavation. This wall was constructed of similar stone to that used in the tower and appears to represent a riverbank revetment. It is unclear whether this feature is contemporary with the

tower or not. Average dimensions of the stones were 0.45m x 0.2m and five rough courses were uncovered, with the wall extending below the depth of the excavation. The wall was exposed for a length of 1.6m, depth of 1.1m and was oriented northwest-southeast. It continued beyond the excavation area to the southeast and remains in situ. The thickness of the wall was not established as it extended outside of the scope of the remediation works. It was not possible to draw the section of exposed wall due to rapidly rising water levels from the river within the trench. After cleaning and photographing, the wall was covered in a layer of terram and the excavation area was backfilled with clean stone. The layer of terram will protect the wall for any future investigations. No artefacts of an archaeological interest were recovered from this area.

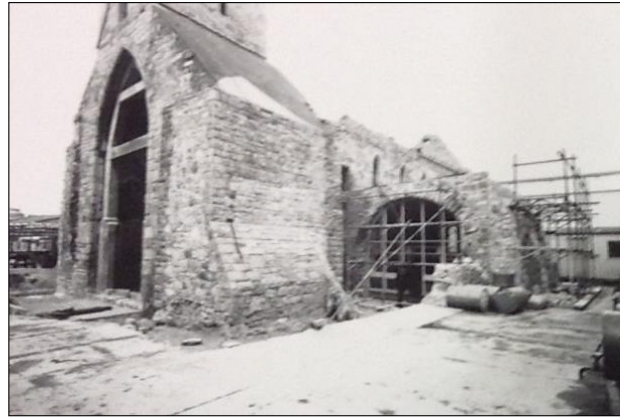
Plate 37 Underside of vaulting in tower    Plate 38 Work in progress on the sacristy

The sacristy is a single cell masonry structure that has been considerably repaired and reconstructed in the last fifty years (Plates 38 and 40). It was restored as an oratory by Smithwicks<sup>4</sup>. There is one door in the west wall. This structure will be retained as part of the Masterplan works and incorporated into a newly created public realm for St Francis Abbey.

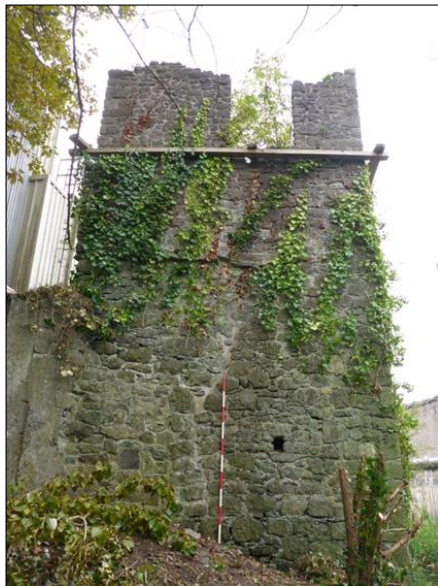
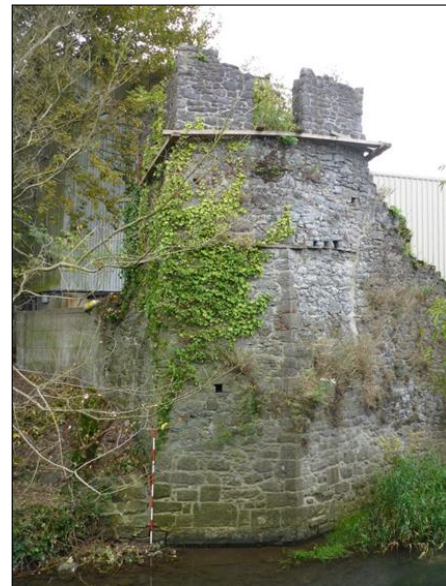
Plate 41 East elevation showing the repair work (2014) Plate 42 Northeast elevation

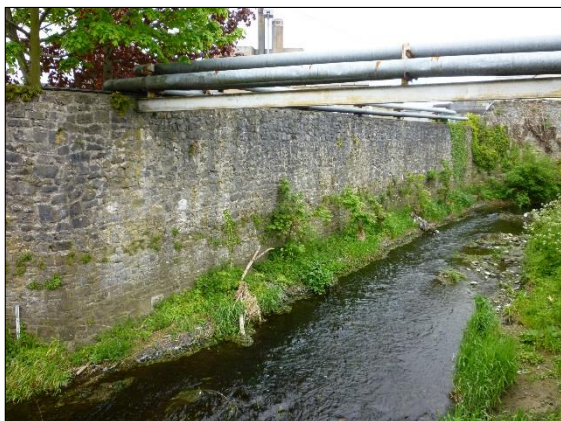
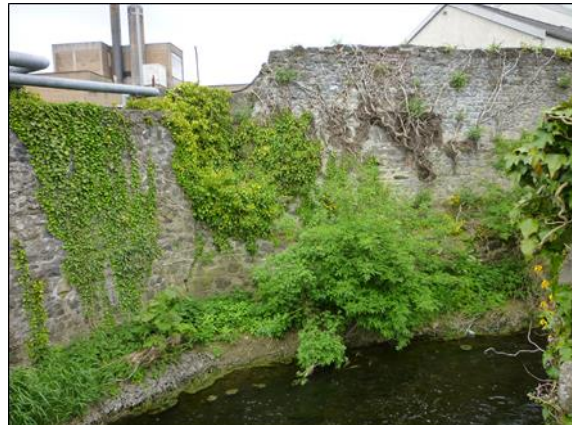
Plates 47-48 Show the present day condition (2015) of the area that was subject to survey 1999-2001

As part of the Masterplan works vegetation regrowth should be removed and a visual inspection of the existing conservation works take place. As part of a long term strategy a maintenance programme could be implemented (Plates 71-74) which would involve an inspection and clearance of vegetation at regular intervals to be determined by a conservation professional.

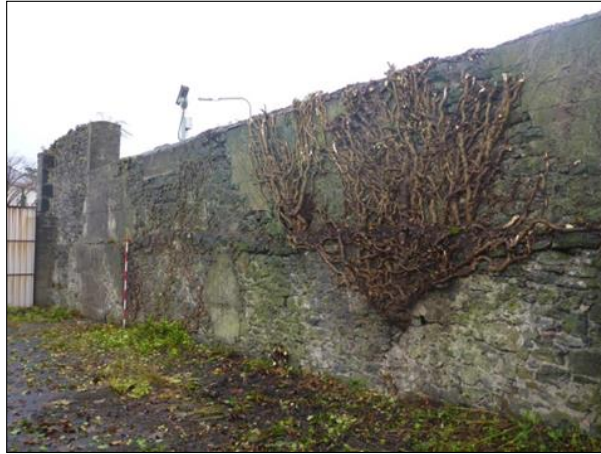
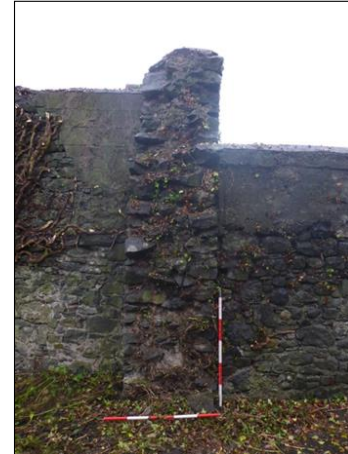
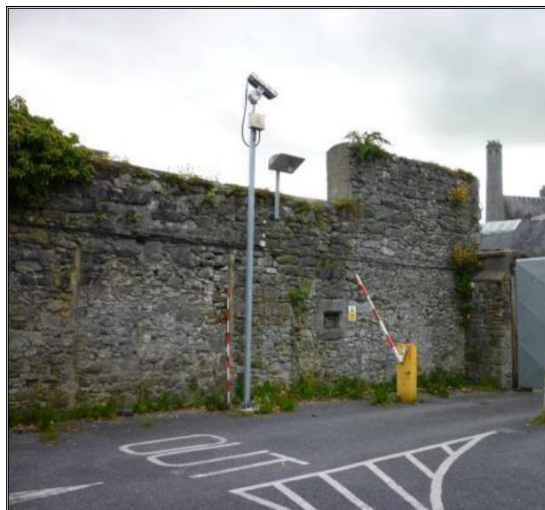
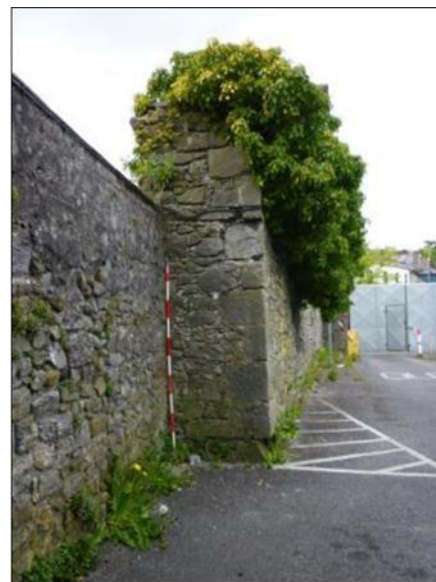
*Plates 49-52: A collection of photographs showing the Bull Inn wall from the southwest face and southwest return after the removal of vegetation and the northeast wall with the chamfered stone ope and southeastern corner.*

- A series of drawings showing stabilisation measures are included in Appendix F. An appropriate design solution should be sought for the successful inclusion of this feature wall into the overall Masterplan development, it could form part of a modern street scape. As part of the Masterplan process the Bull Inn will now be open to view by the public and part of the public realm of Kilkenny further enhancing the medieval fabric of the city.

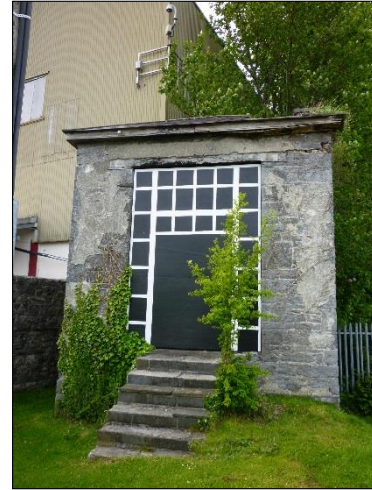
*Plate 54 Sentry Box Tea House*

The following account of the latter teahouse is taken from Chapter 7 River transport and leisure by Adam Slater in *The River Nore Drainage Scheme*<sup>10</sup> The building measures 5.9m (north-south) by 4.8m (east-west) and is approximately 7.5m from the present ground to eaves. The roof is timber framed, sloped to the east and west, and slated although showing extensive damage. Externally the walls are unevenly coursed and carefully mortared, with large stressed quoins on all corners. The eastern wall has no doors or windows and is surmounted centrally by a tall brick chimney.

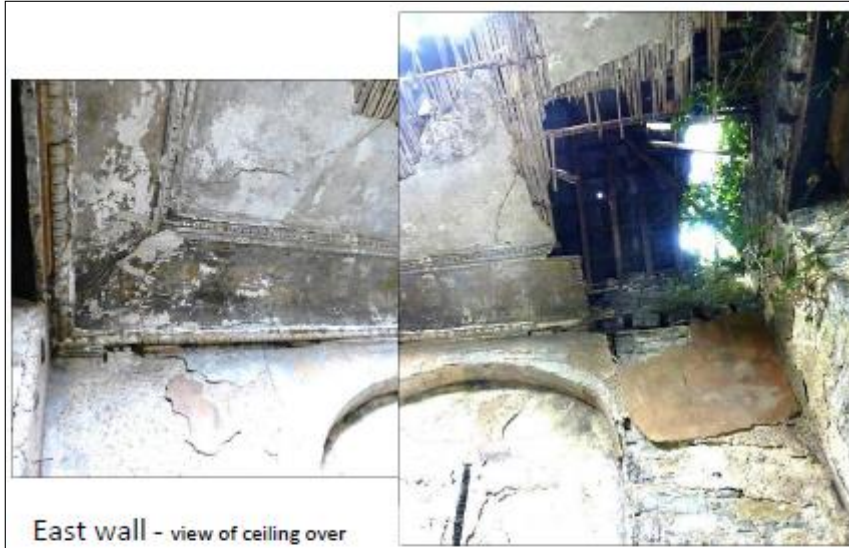
East wall - view of ceiling over

**Note Condition of Ceiling and roof over**

It is assumed that the only access gained to the interior is that need for the purposes of installing the bracing to the two large openings.  
Access should only be ventured as far as the area immediately under the lintels of those openings.  
Thus access to the rear north window will be from that side

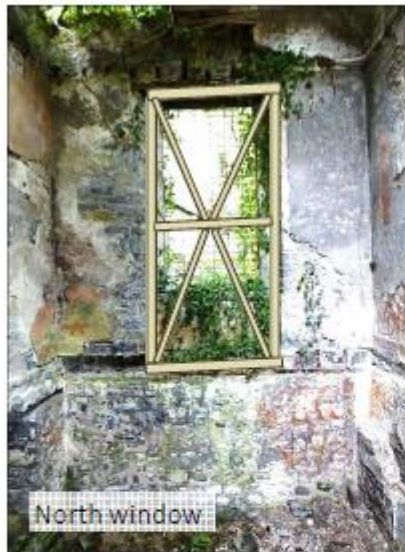
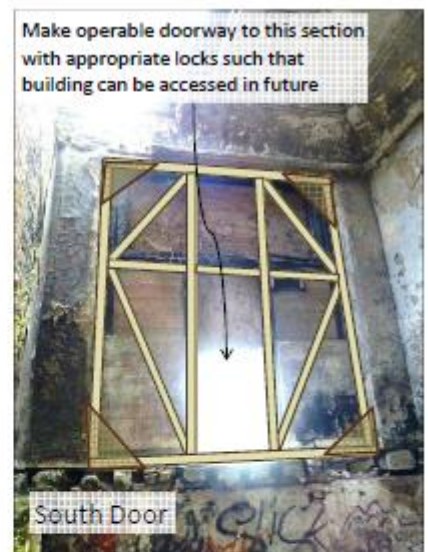
Plates 55-56

Make operable doorway to this section with appropriate locks such that building can be accessed in future

**Brace and secure doorway and large rear window**

- Install vibration monitors.
- Crop vegetation.
- Digitally survey building and submit to design team and Kilkenny County Council.
- Proceed with bracing doorway and large rear window and secure the building from unauthorised entry.
- Carefully separate adjoining walls from buildings that are to be demolished to reduce any vibration on the Tea House.
- Proceed with adjoin demolition works.

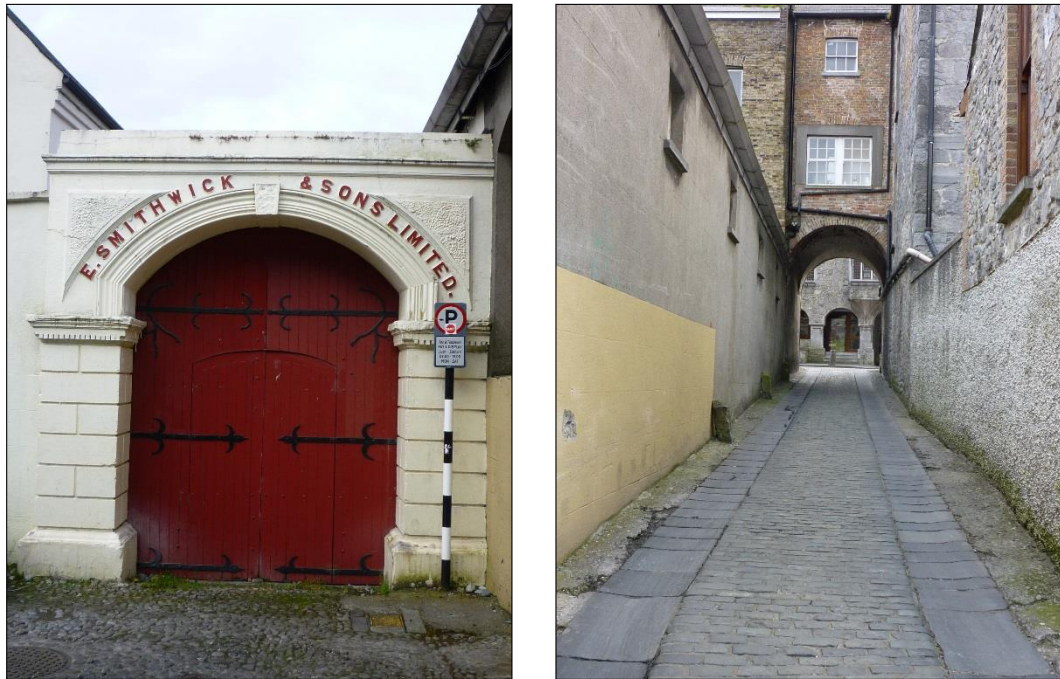
Plates 57-58 Original gate and laneway

The original gateway (NIAH 12000087) to the brewery dates to about 1875 and fronts onto Jenkin's Lane (Plate 18). The gateway comprises a segmental-headed carriageway with a pair of painted rusticated rendered piers having dentilated moulded cornices. There are tongue-and-groove timber panelled double doors with decorative wrought iron hinges, moulded archivolt having keystone, raised lettering, tooled rendered panels. This entrance feature forms a picturesque feature in the streetscape of Jenkin's Lane. The limestone cobbling of the lane with cut-limestone flagged wheel tracks is an attractive and protected (NIAH 12000086) aspect of the streetscape. This laneway and entrance while located outside the Masterplan area can provide pedestrian access into towards the area and out to Parliament Street.

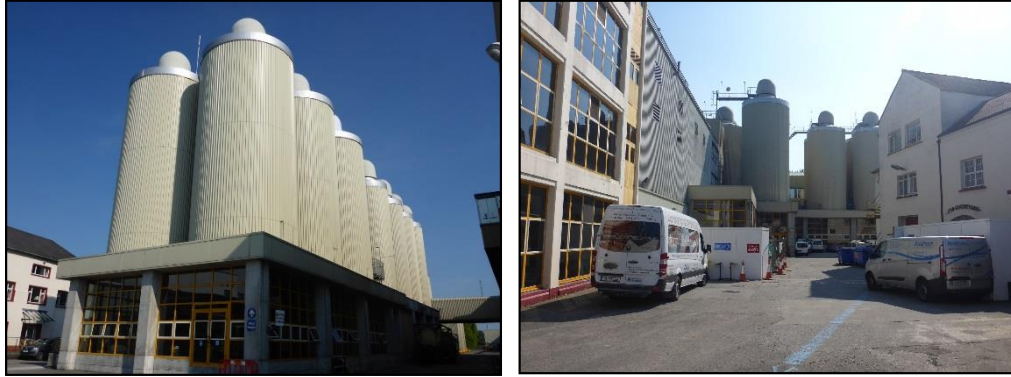
Plates 61-62 Maturation Building external elevations

The Maturation building has been redundant since the cessation of brewing operations at the brewery site. The building comprises a single-storey concrete structure that is utilised as a support to the 22 large maturation tanks of the brewery. The late 20<sup>th</sup> century structure was an integral component of the brewery operations on the site, where the tanks were used for the maturation and storage of beer. Processes such as centrifuging and bottoming of yeast as well as maturation over 14 days took place in the Maturation Building.

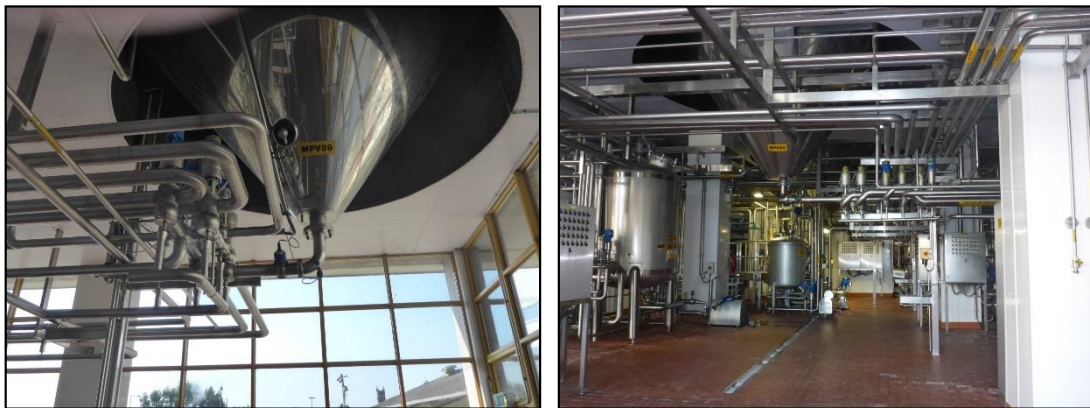
Plates 63-64 Maturation Building internal workings

The interior of the building is largely open and filled with natural light. The spaces are divided by rendered concrete columns. The base of the maturation tanks protrude from the ceiling and are connected to a series of valves and pipes that are controlled automatically. The building is well ventilated with window openings within the glass pane structure and a number of emergency and double doors leading to the exterior. The floor is tiled and drains are present to distribute any excess liquid, spills through a waste system. The only separate room in the structure is a small sampling and quality control station.

Each multipurpose vessel (MPV) is numbered, with MPV 68-89 labelled forming a total of 22 vessels. Beneath these vessels are control panels which automate the different lines to and from each vessel. The following plates show the equipment (metal vats, pipes and control panels) that is still *in situ* around MPV 89 and 69.

The large maturation tanks sitting on top of the main structure make this a highly visible and distinctive building within the brewery site. While the Maturation building is of a modern industrial and technical heritage interest the removal of the tanks as proposed with the existing planning permission will result in a significant loss of integrity.

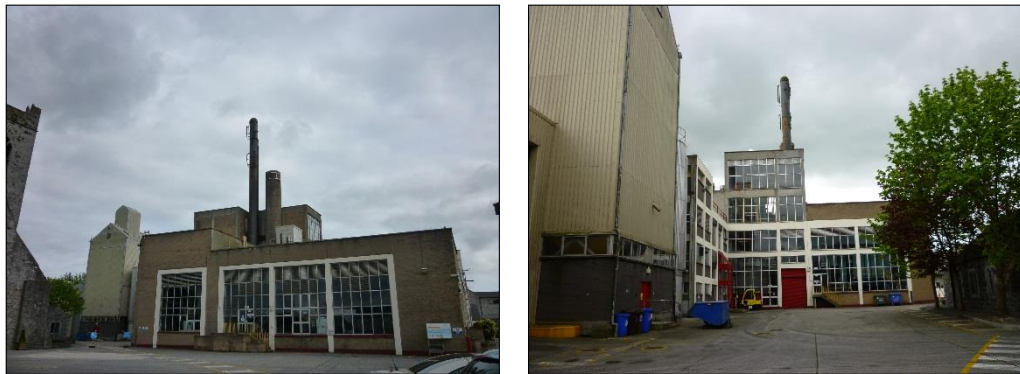
*Plates 65-66 Brewhouse northern and northeast external elevations*

The photograph below (Plate 65) shows the northern elevation of the Brewhouse, which is a concrete structure with a steel framed clad infill elements such as brick built in the 1960's. Large expanses of symmetrically laid panes of glass punctuate the elevations of the structure ensuring plenty of light to the interior. The structure has a number of accumulated extensions up to the 1980's and extends to five stories high along its eastern elevation and four stories at the northeast. The structure as part of the large scale brewing industry at St Francis' Abbey Brewery, Kilkenny, is of industrial heritage interest.

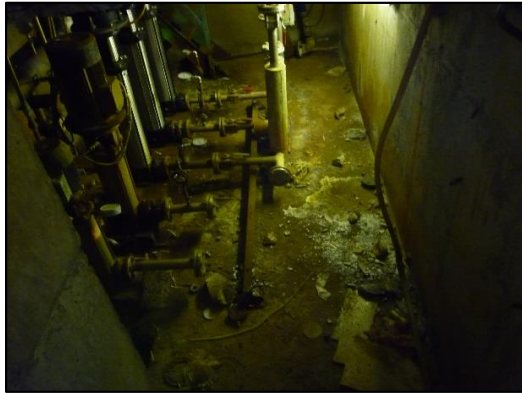
Plate 68 Brewhouse subterranean plant room

The interior of the structure was stripped out and modernised in the 1990's. The building functioned as a brewhouse and contained the boiler house, engine room and operation centre. At the northern end are the only subsurface stores of the

entire structure, accessed by a ladder. These present as narrow confined spaces and appear to relate to the location of the cloister walk identified by Sweetman revealed during the archaeological monitoring programme in the 1970's and would have formerly formed part of the cloister range (Figure 34). The floor level recorded for this structure is +43.58OD and the original ground level recorded on St Francis' Abbey is +44.61OD putting the cellars approximately 1.03m below the original ground level.

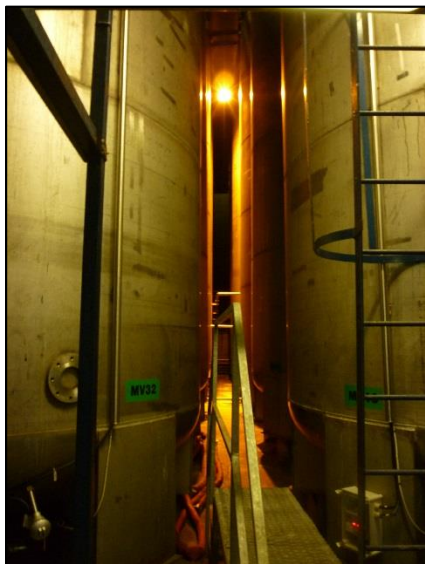
Plates 70 and 71 Large metal vats within the Brewhouse

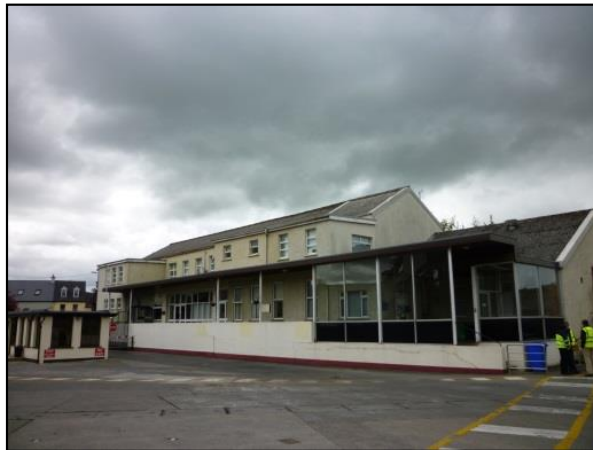
Plate 72 Mayfair Building – front elevation

The 1930's structure consists of a mass concrete frame and is two stories high to the southeast where a covered walkway provides access to offices along the front of the building, it is not considered to be of architectural heritage significance. The rear of the structure is built up against the city wall and the River Breagagh.

It is partially located on the site of the 'Horse Barracks' which were built in 1699 and later demolished to make way for the expanding brewery. Part of the city wall along the River Breagagh could have been reused, built up to once form the northern extent of this former building and the existing wall could be the last upstanding remnants of the Horse Barracks (Plates 71-72). A separate archaeological and architectural study on the Mayfair Building has been produced by Kilkenny Archaeology (2014)<sup>12</sup> in order to inform the proposed redevelopment of this building.
