# ABBEY QUARTER MASTERPLAN AREA ARCHAEOLOGICAL STRATEGY

KILKENNY COUNTY COUNCIL

COURTNEY DEERY HERITAGE CONSULTANCY LTD

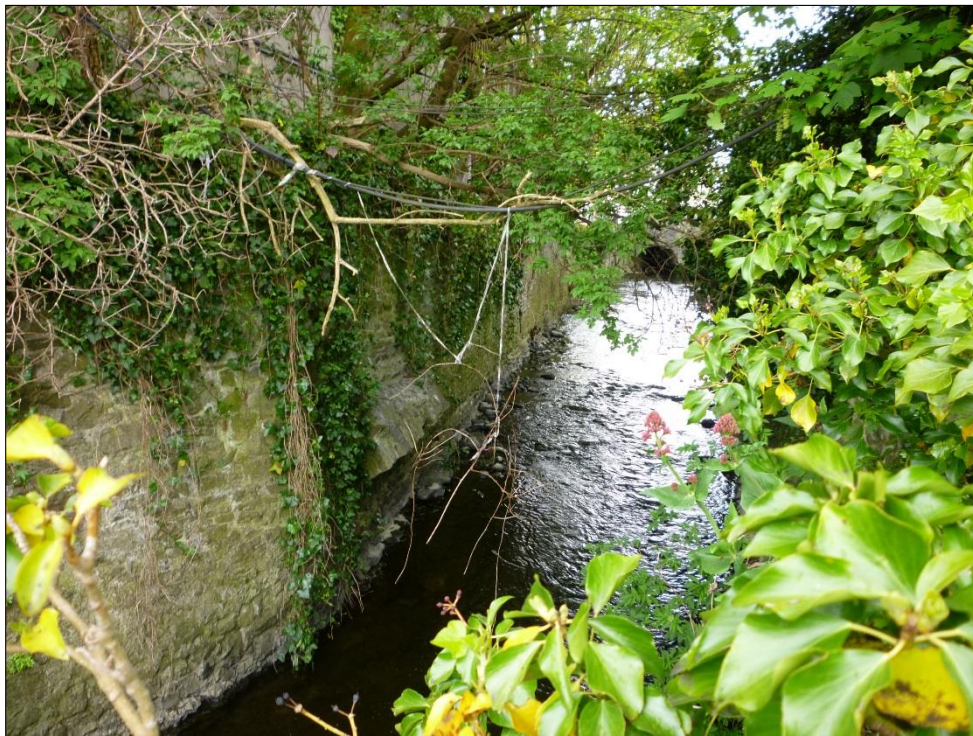
*Plate 75 City Wall to the rear of the Mayfair Building taken from the east showing spring stones of a former bridge site*

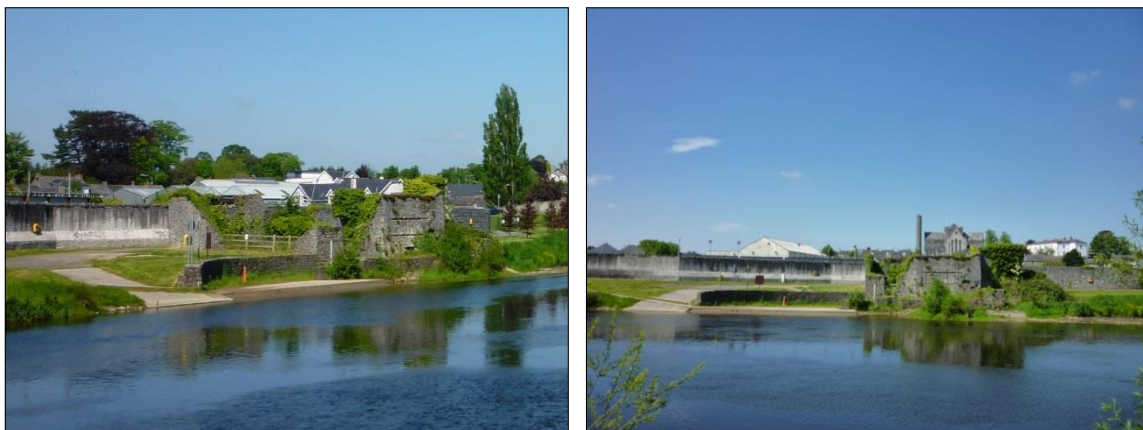
*Plate 77 and 78 View to the mills taken from the eastern bank of the River Nore*

The ruined Mill building is placed on the western banks of the River Nore with a slipway present to the south of the structure. The setting of the site has altered recently with the development of the KCAS. Indeed for the purpose of this report the ruin could not be accessed for a detailed assessment as hoarding has been placed around the protected structure in order to protect it from ongoing construction works.

In recent years, the structure formed part of the public realm with public access around the exterior of the structure, however no access was provided to the interior with a low wooden fence preventing entry. At a cursory inspection the remaining masonry appears to be in a reasonable condition however it is heavily overgrown with vegetation.

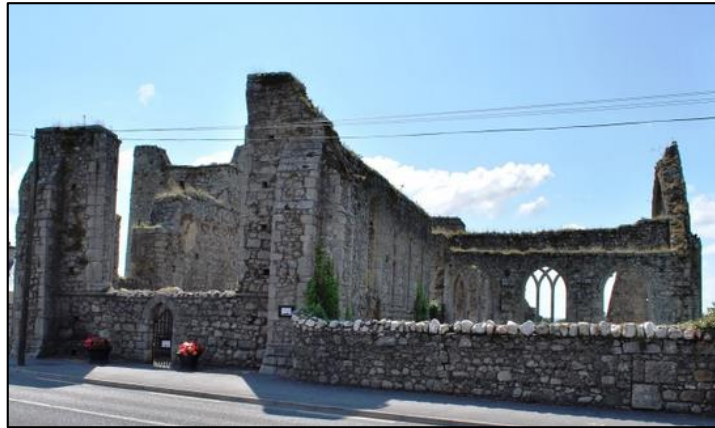
*Plate 87 Franciscan Friary at Castledermot, showing transept, through excavation it is known that St Francis' Abbey Kilkenny has a similar layout and it is possible to visualise what the transept would have looked like from this photograph<sup>7</sup>.*

The layout at the friary in Castledermot which was founded c.1247 is also very similar to that at Kilkenny, with a transept and aisle to the north of the nave and a cloister to the south (Halpin & Newman 2006<sup>5</sup>). The proportions of both churches are similar in that there are approximately 8m in width while St Francis' Abbey is some 6m longer standing at 47m. In both cases the northern aisle was partially destroyed to accommodate the construction of the transept chapel. Both have the same plan, three chapels with a row of arches creating a false aisle to the rear. This latter feature is found in other Franciscan transepts but the triple chapels are unique to these two sites. Kilkenny has the largest of the 25 known Franciscan transepts in the country<sup>6</sup>, and the transept at St Francis' Abbey is estimated at 18 x 20m. This is large in size when compared to Castledermot at 11 x 11.5m.

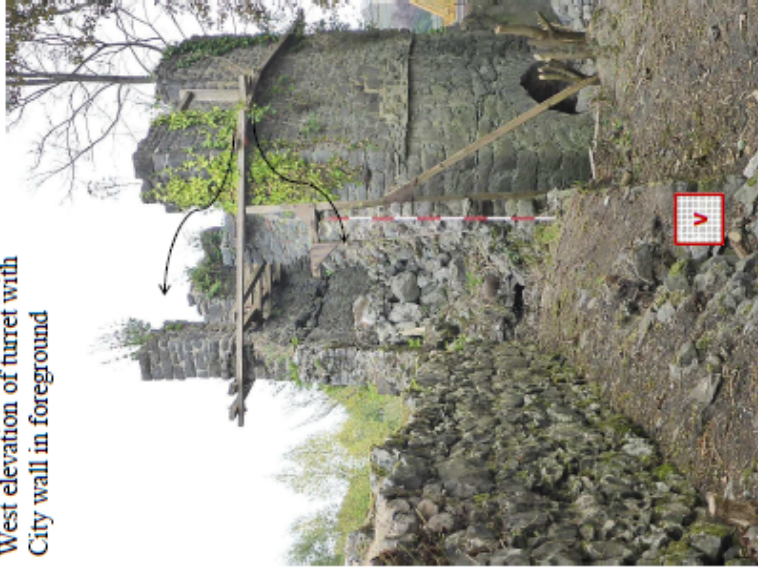
**West elevation of turret with City wall in foreground**

**Stabilisation works required listed in assumed sequence of installation**

i) Install 2 vibration monitors, one on tower and one on City wall. Locations to be agreed on site with Engineer and may require additional bracketry to be fixed to masonry to ensure monitor properly secure. Approximate locations shown thus V

*A vibration cut off threshold of 4 mm/s peak particle velocity (PPV) will be adhered to. The vibration monitors should be linked to alarm systems such that any exceedance in vibration level is clearly instantly visible and is sufficiently audio alarmed that any personnel in the large car-park area to the west of the tower is alerted. A full record of the monitoring is to be kept and downloaded at regular intervals (minimum daily) and/or on request and made accessible to the design team. Any exceedance of pre-set vibration limits will result in work stoppage, assessment of cause of exceedance and future avoidance of such.*

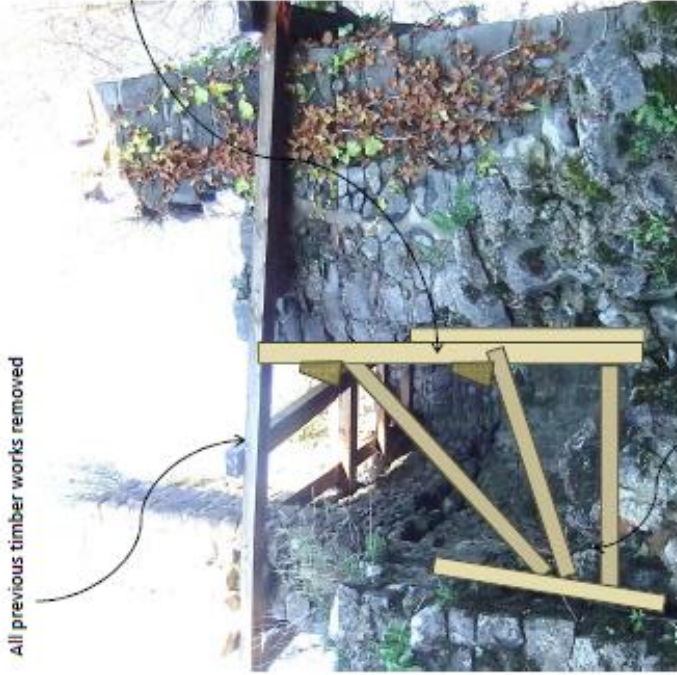
All previous timber works removed

Timber propping:-

- drape plastic approx 300mm wide down / against wall to be propped
- Install timber propping limiting any fixings into existing to the minimum
- Apply gusset plates of plywood and timber folding wedges as necessary to secure propping
- Inject expanding foam between propping and plastic to ensure tight fit to masonry
- Cut back foam and plastic flush with sides of timber

2no props to inner face City wall with hook over top of wall to restrain against movement into wall walk - as previous propping detail

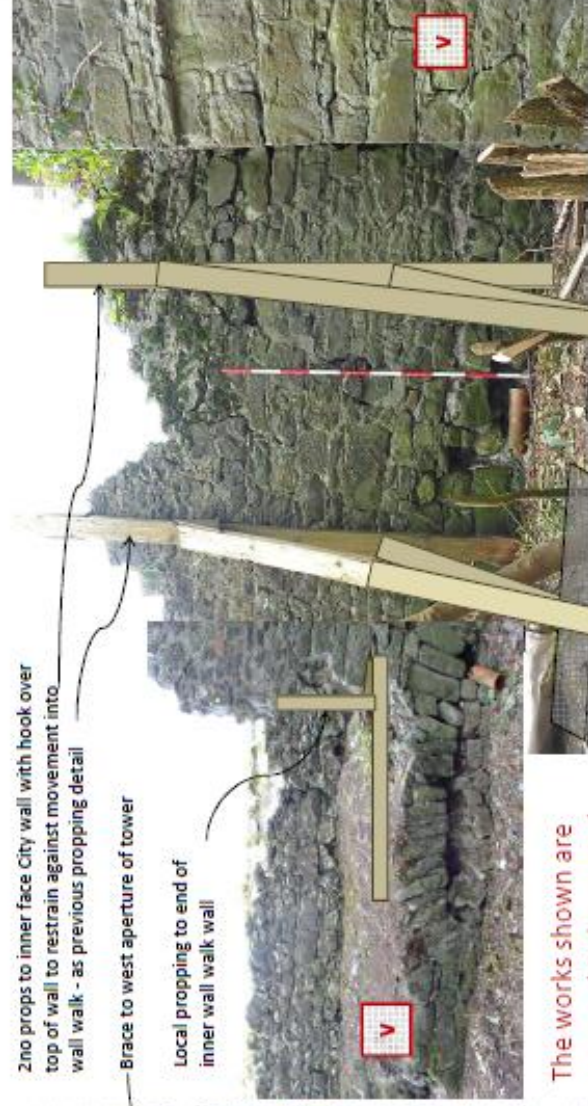
Brace to west aperture of tower

Local propping to end of inner wall walk wall

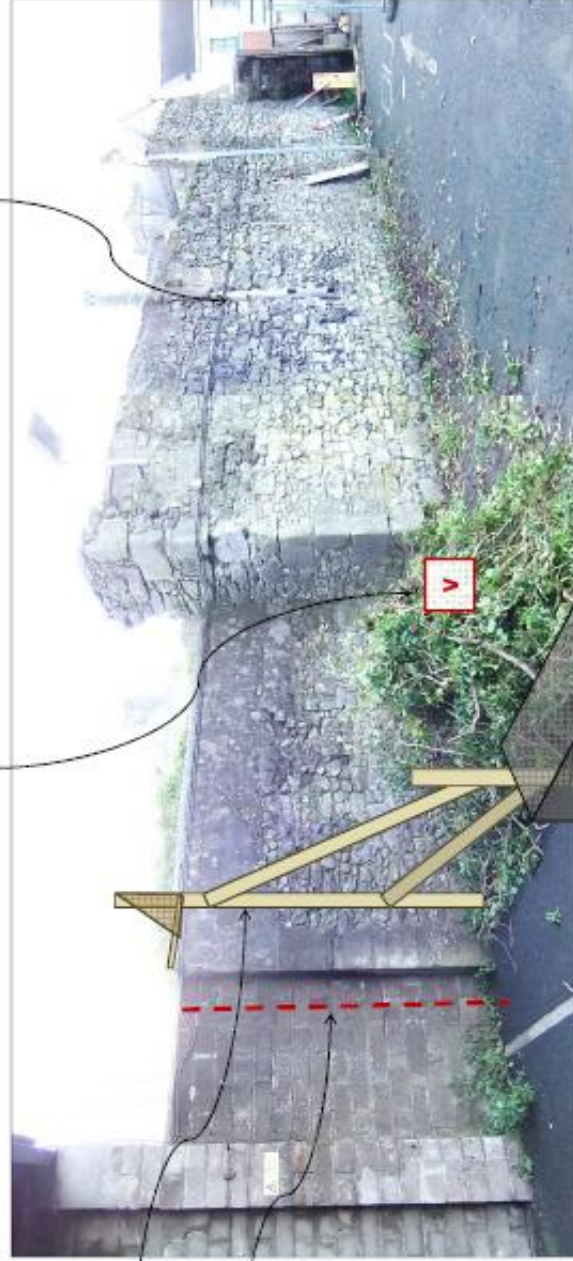
Stabilisation works required listed in assumed sequence of works

- i) Install 1 vibration monitor at the wall base. Approx location shown thus v Actual location to be agreed on site with Engineer  
*A vibration cut off threshold of 4 mm/s peak particle velocity (ppv) will be adhered to. The vibration monitor should be linked to alarm systems such that any exceedance in vibration level is clearly instantly visible and is sufficiently audio alarmed that any personnel in the vicinity is alerted. A full record of the monitoring is to be kept and downloaded at regular intervals (minimum daily) and/or on request and made accessible to the design team. Any exceedance of pre-set vibration limits will result in work stoppage, assessment of cause of exceedance and future avoidance of such.*

- ii) Install propping to wall in location shown - see drg 204
- iii) Saw cut blockwork immediately to left hand side of random rubble wall
- iv) Proceed with adjoining demolition works watching for any exceedance in vibration levels
- v) Leave propping in place at handover of works

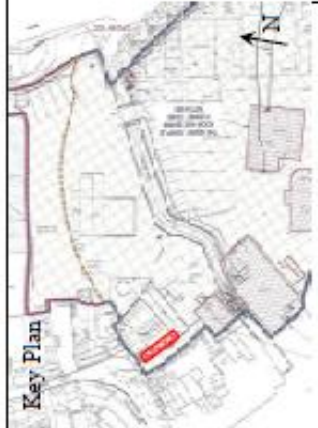
### Bull Inn Wall

The works shown are assumed to be carried out as part of 2015 Demolition contract

Random rubble wall left as is but to be protected from demolition works with suitable exclusion zones or hoardings  
 Note five pipe built into wall to be left in place even if deemed to be asbestos containing as removal will damage wall. Pipe to be removed as part of repair works (Not part of Demolition contact)

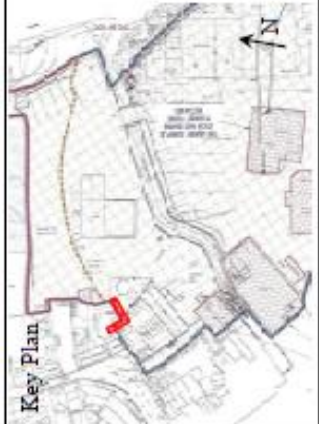
Boundary Wall north end of site adjoining link road

West facing elevation

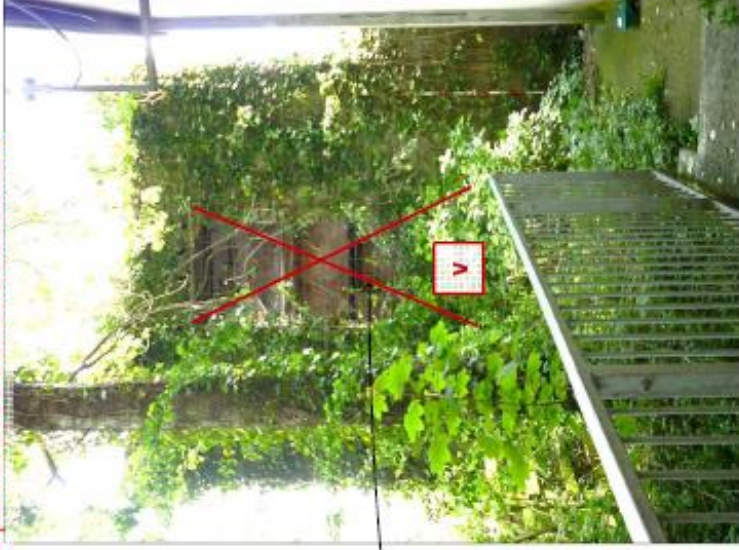
South elevation

North elevation - vegetation to be close cropped

These works shown on Sheets 1 and 2 are assumed to be carried out as part of 2015 Demolition contract
